TOWNSHIP OF CHAPLEAU

MUNICIPAL STRUCTURE INVENTORY AND INSPECTION - 2013

AECOM

December, 2013

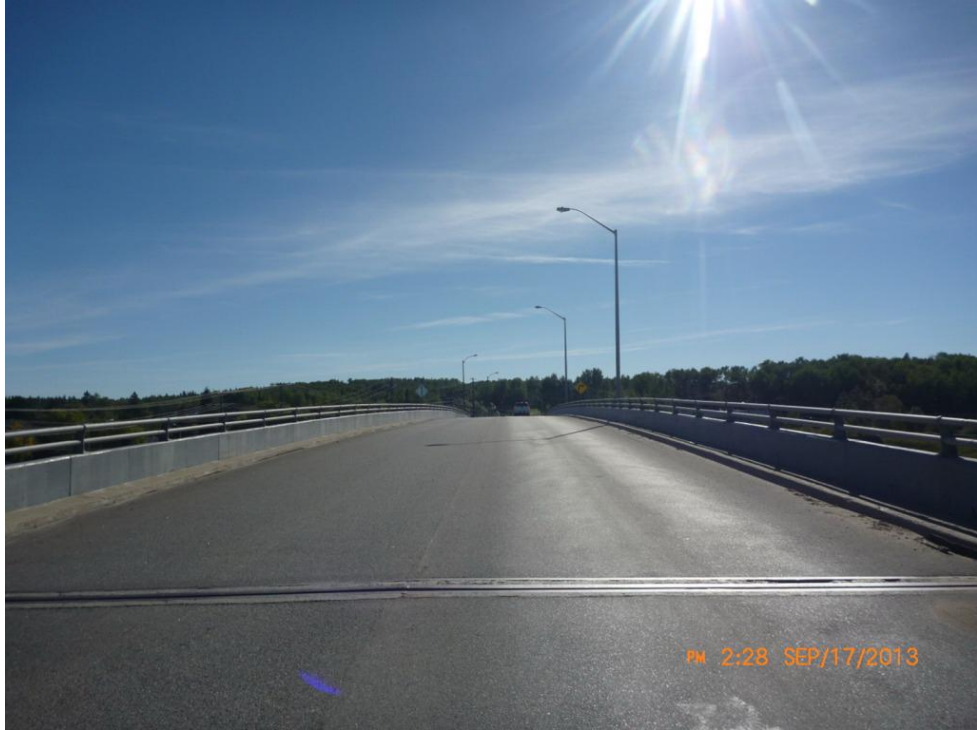
Comments: LOOKING WEST OVER STRUCTURE

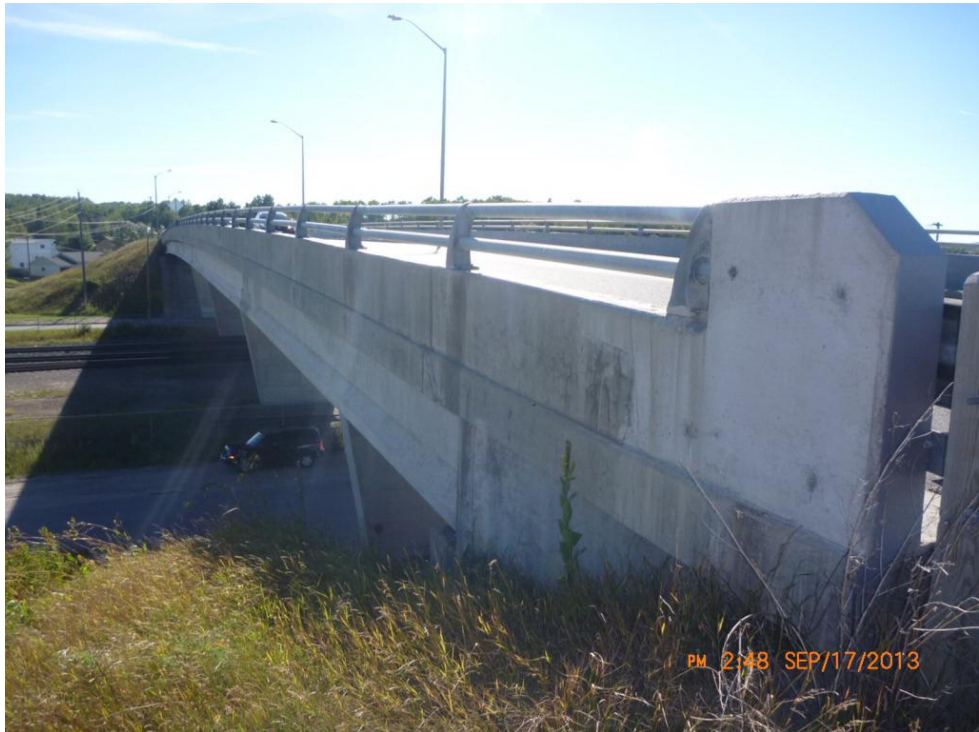
Comments: SOUTH ELEVATION

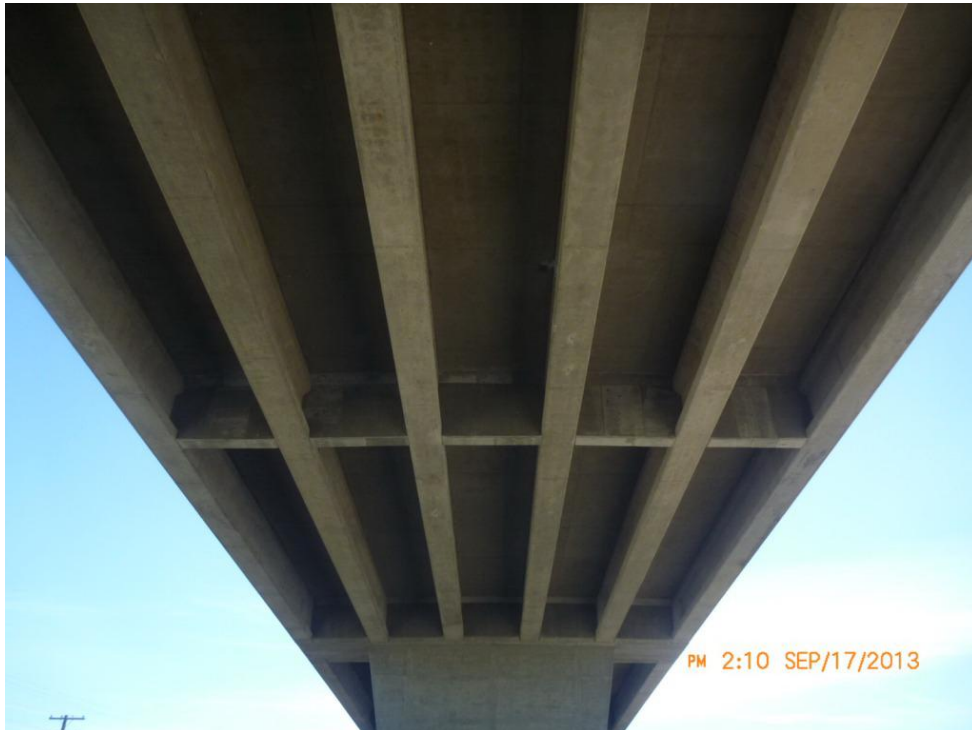
Comments: TYPICAL SOFFIT

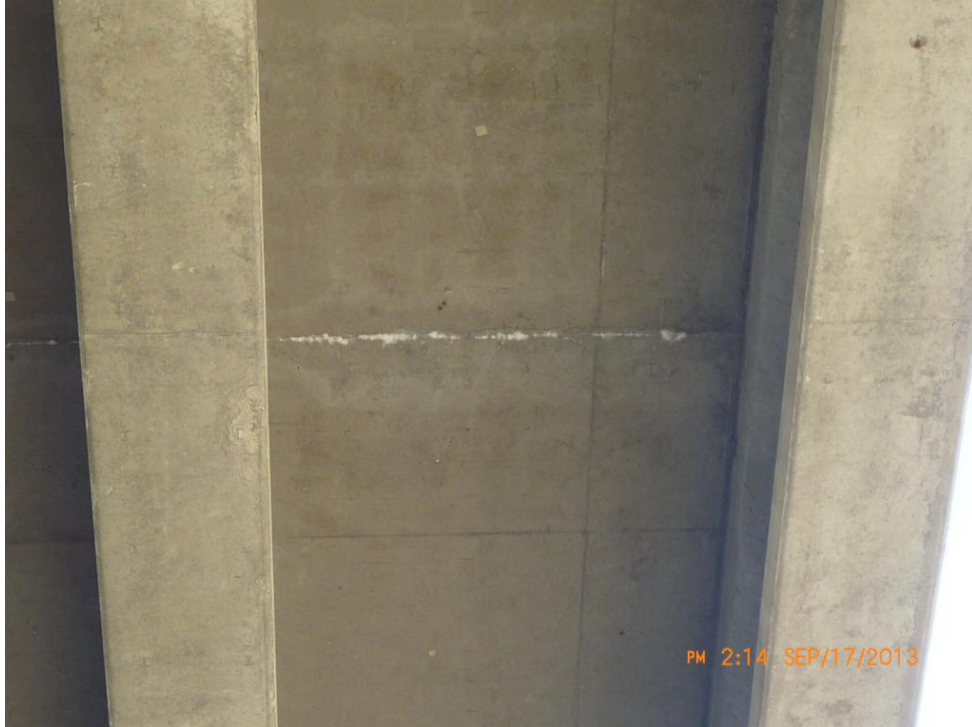
Comments: NARROW STAINED CRACK ON DECK SOFFIT

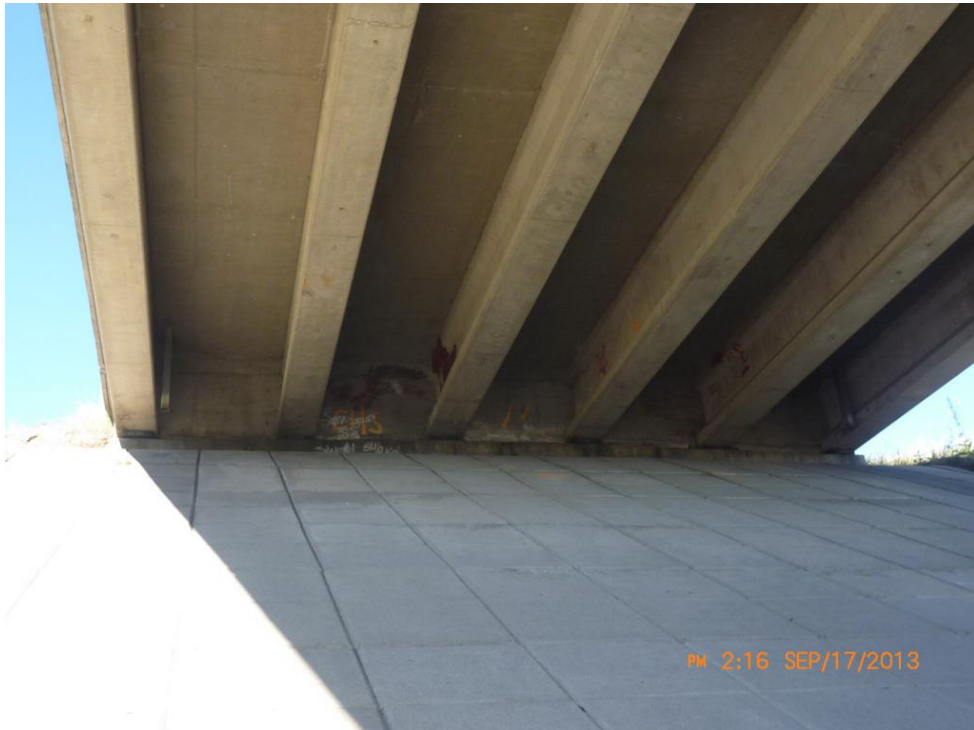
Comments: EAST ABUTMENT

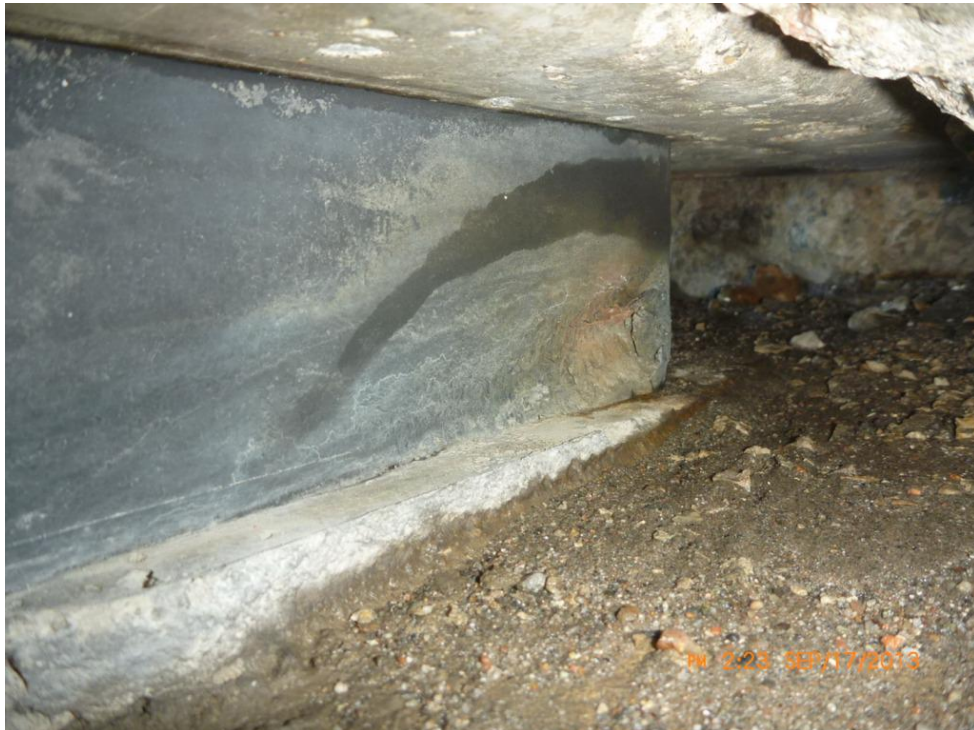
Comments: GOUGE OUT OF ABUTMENT BEARING PAD

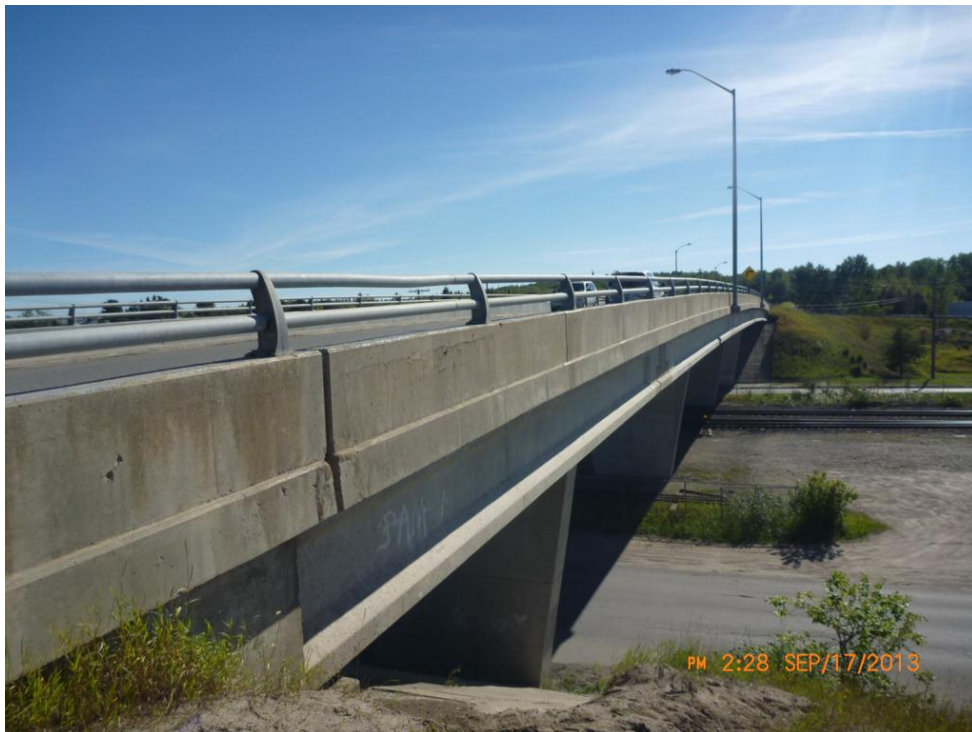
Comments: NORTH ELEVATION

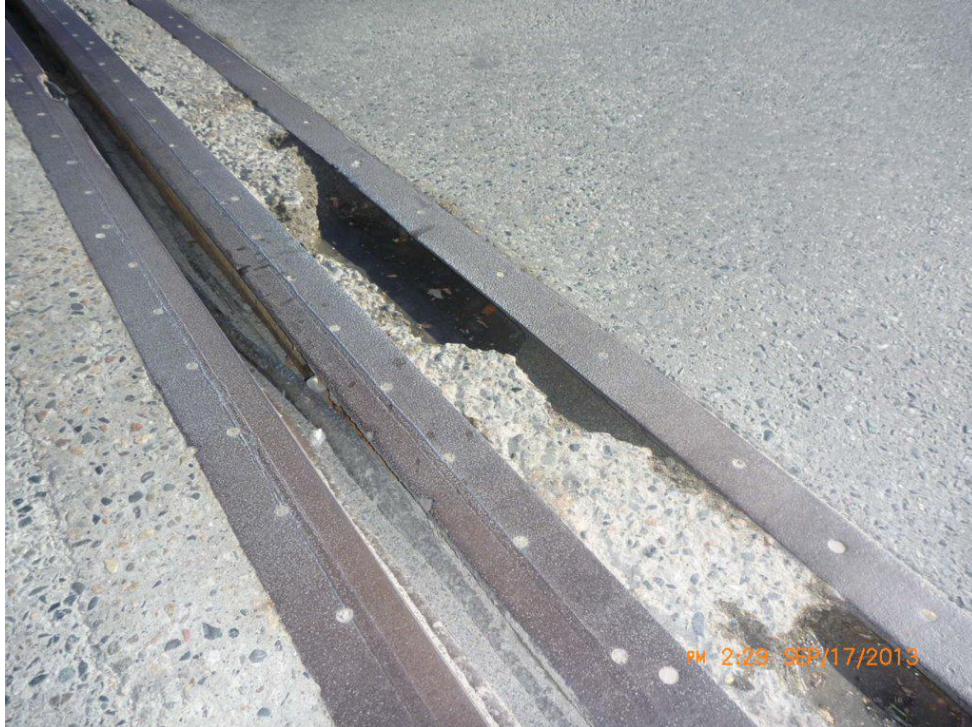
Comments: SEVERE SPALLING OF EAST JOINT END DAM

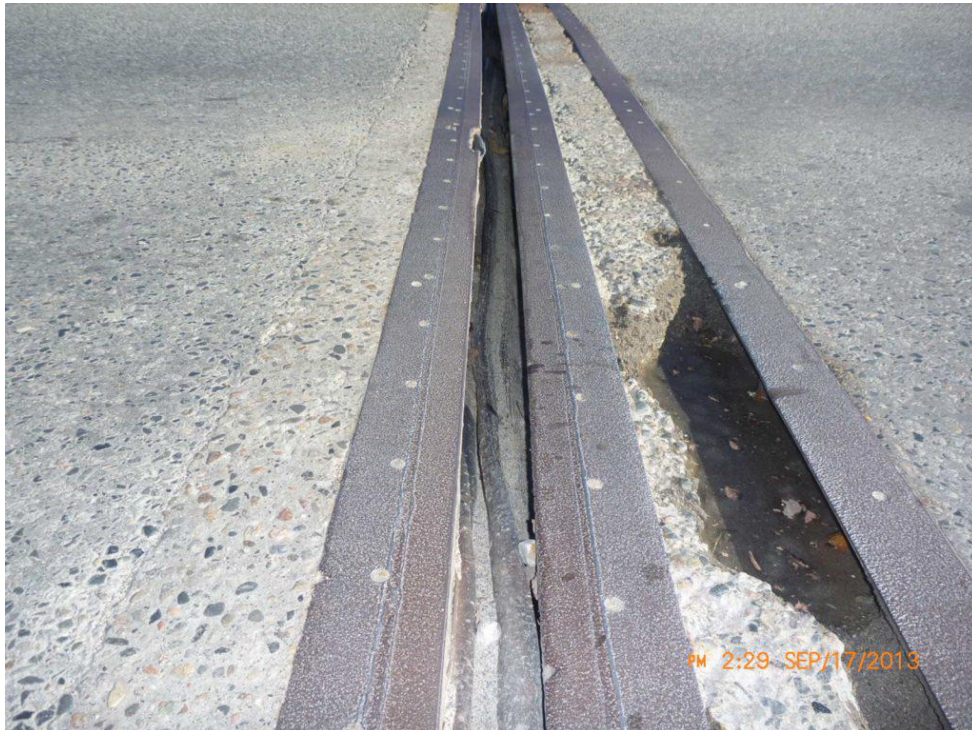
Comments: TWISTING OF EAST JOINT SEAL

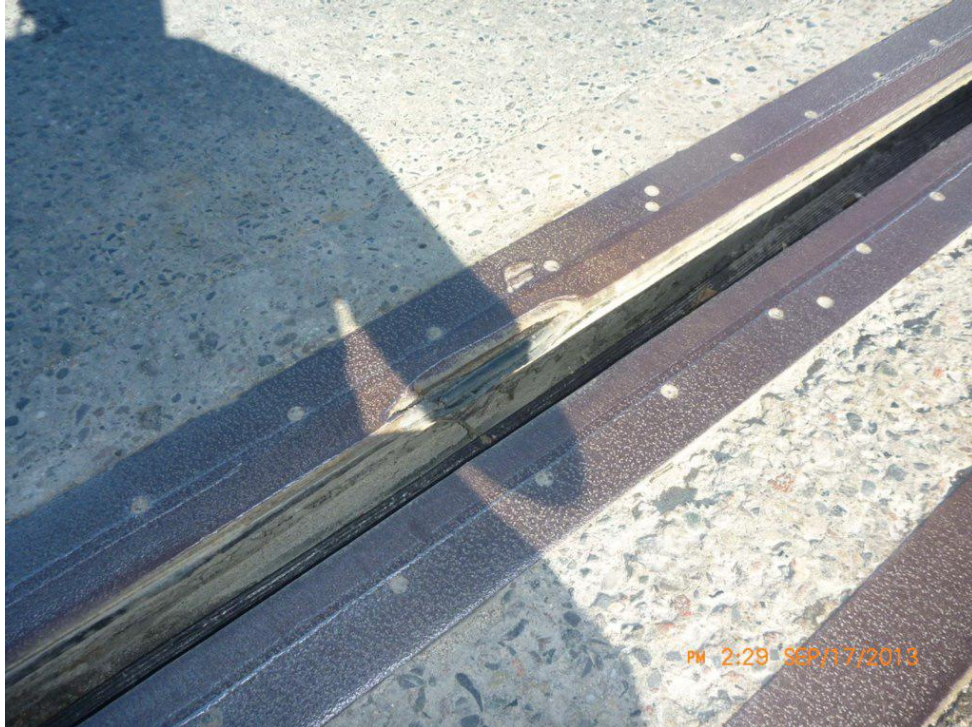
Comments: MISSING SECTION OF ARMORING ANGLE

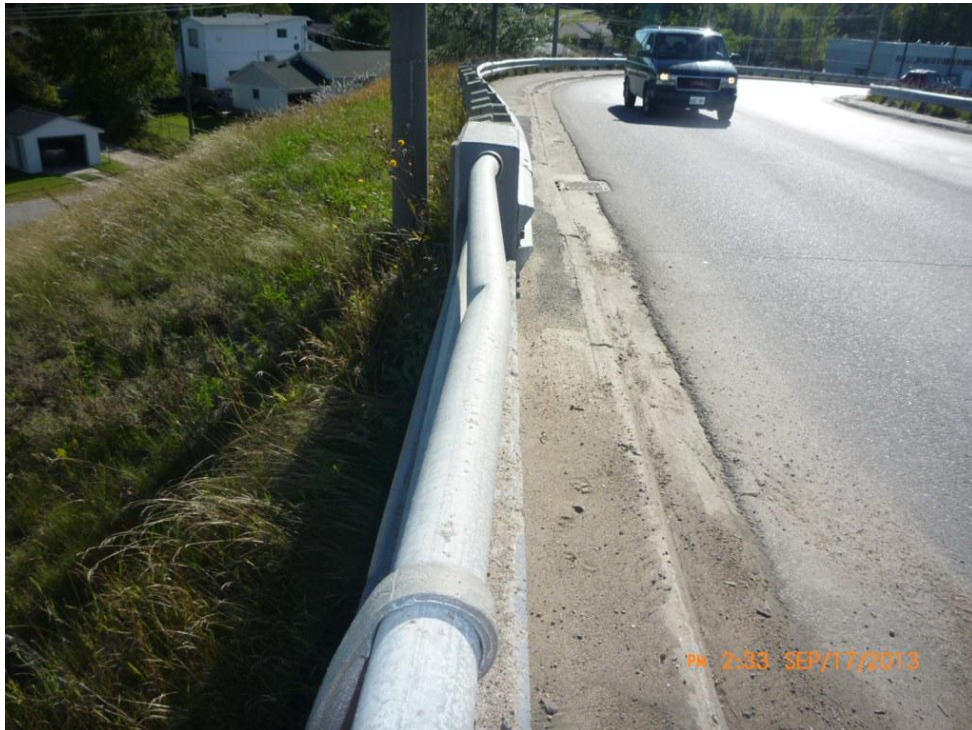
Comments: COLLISION DAMAGE TO HANDRAIL

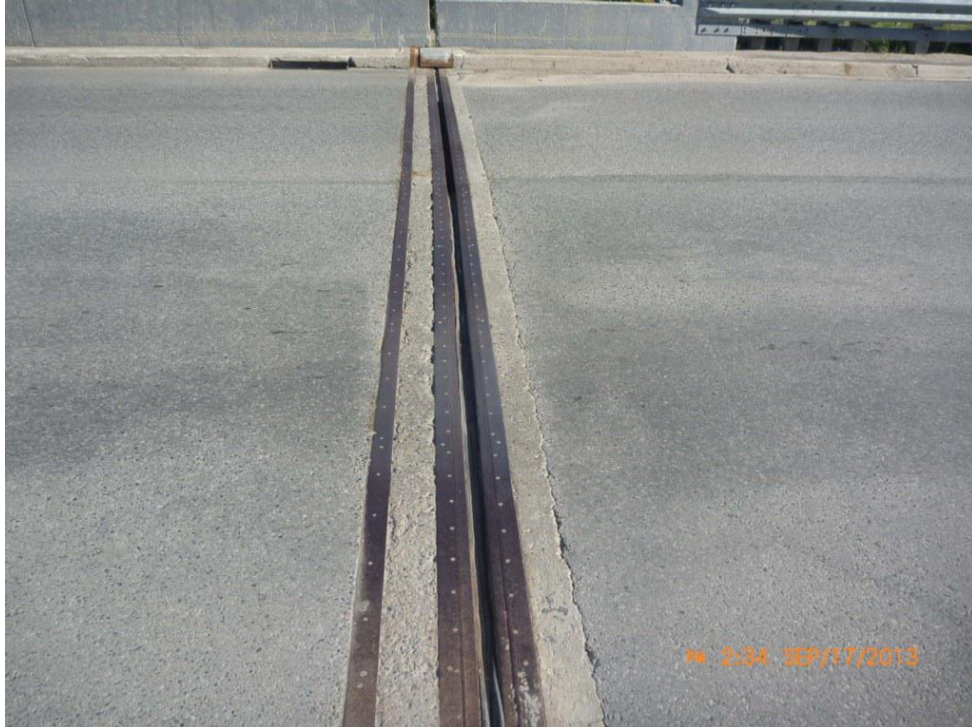
Comments: WEST EXPANSION JOINT

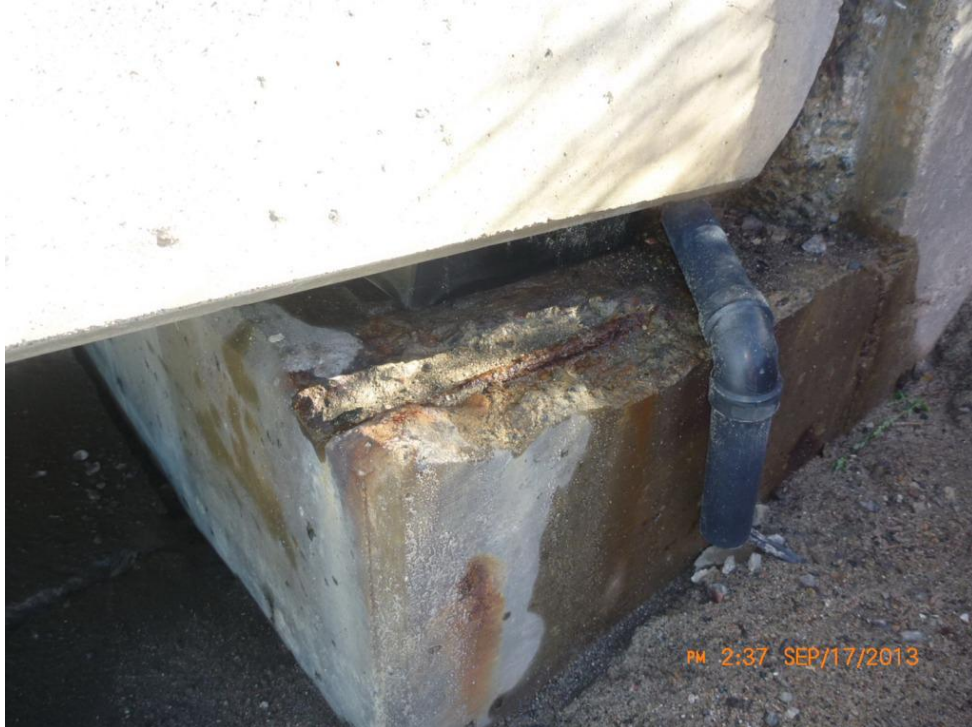
Comments: SPALLING OF ABUTMENT SEAT

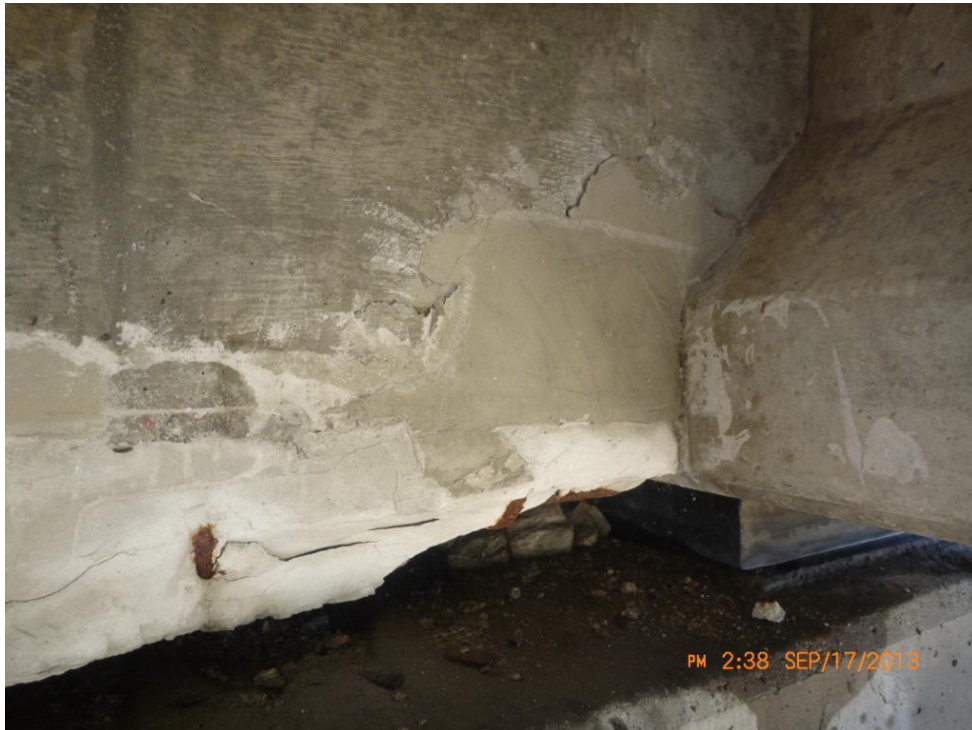
Comments: DEBONDED PATCH AT WEST ABUTMENT DIAPHRAGM

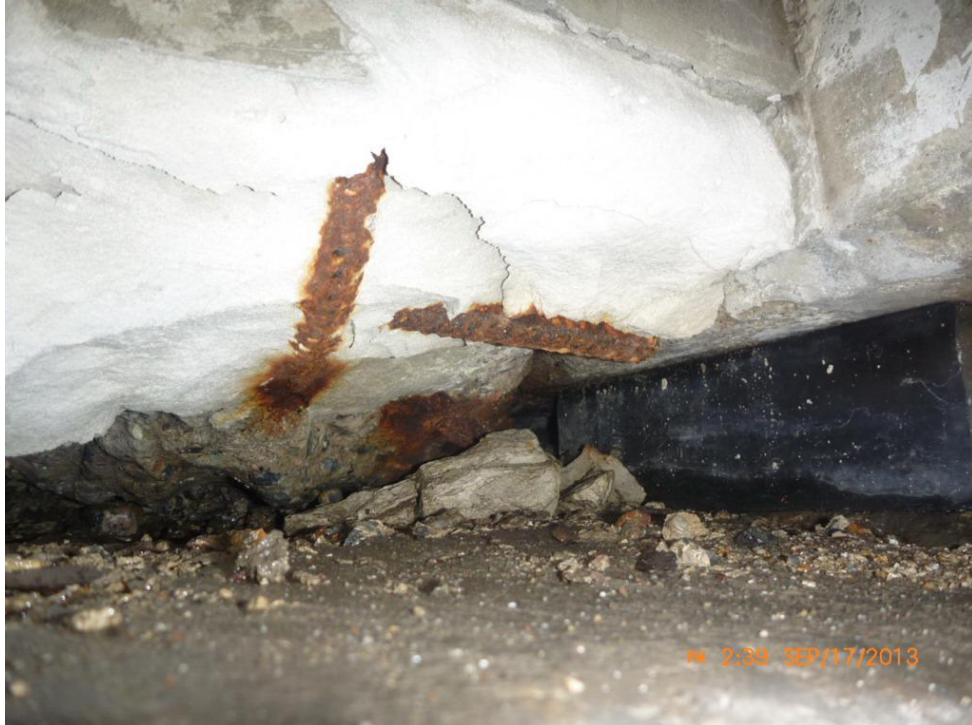
Comments: SPALLING OF WEST ABUTMENT DIAPHRAGM

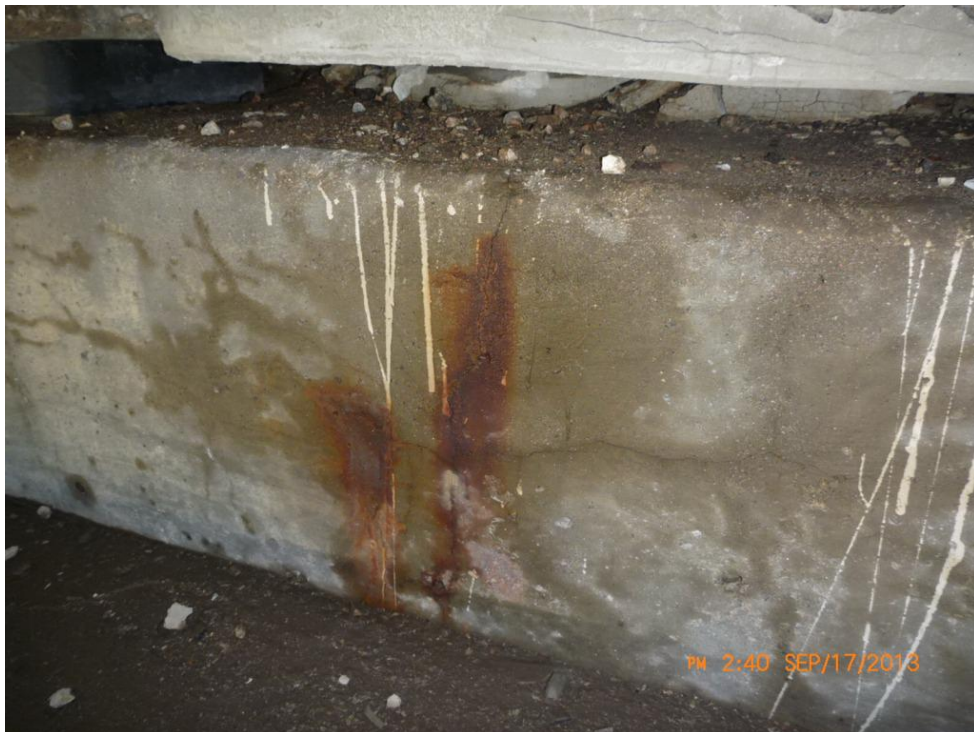
Comments: DELAMINATION ON ABUTMENT WALL

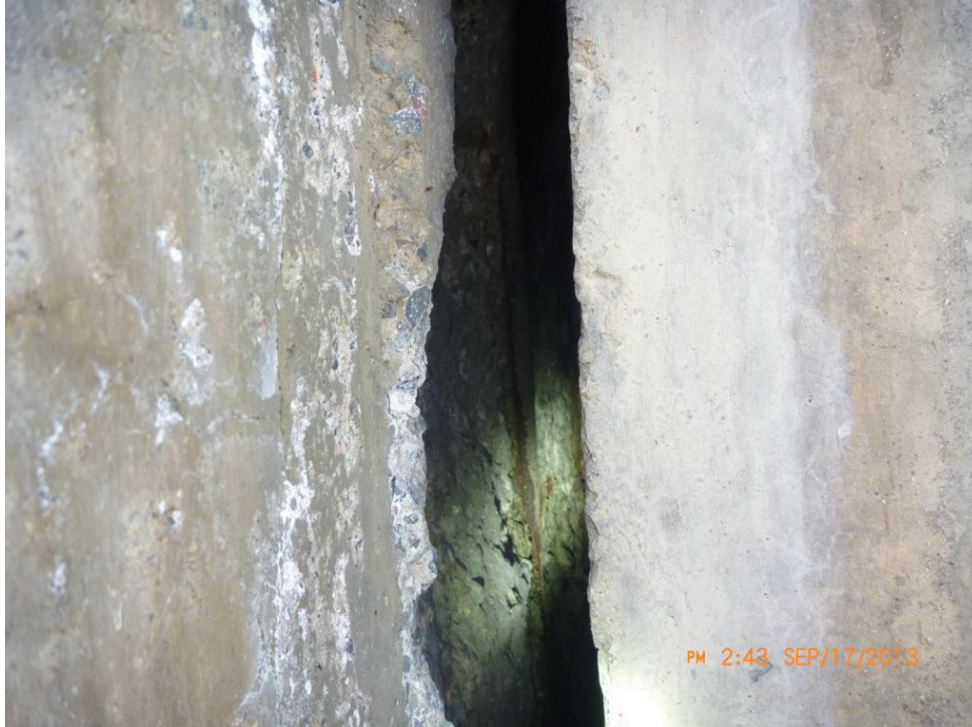
Comments: SEVERE SPALLING OF BALLAST WALL

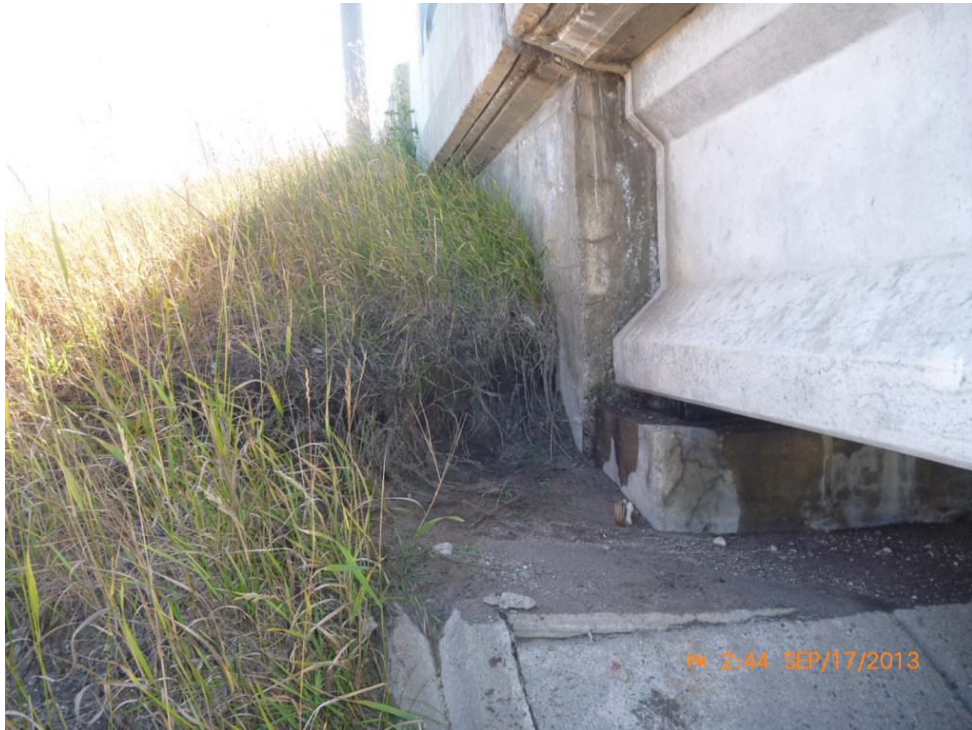
Comments: SEVERE EROSION OF EMBANKMENT

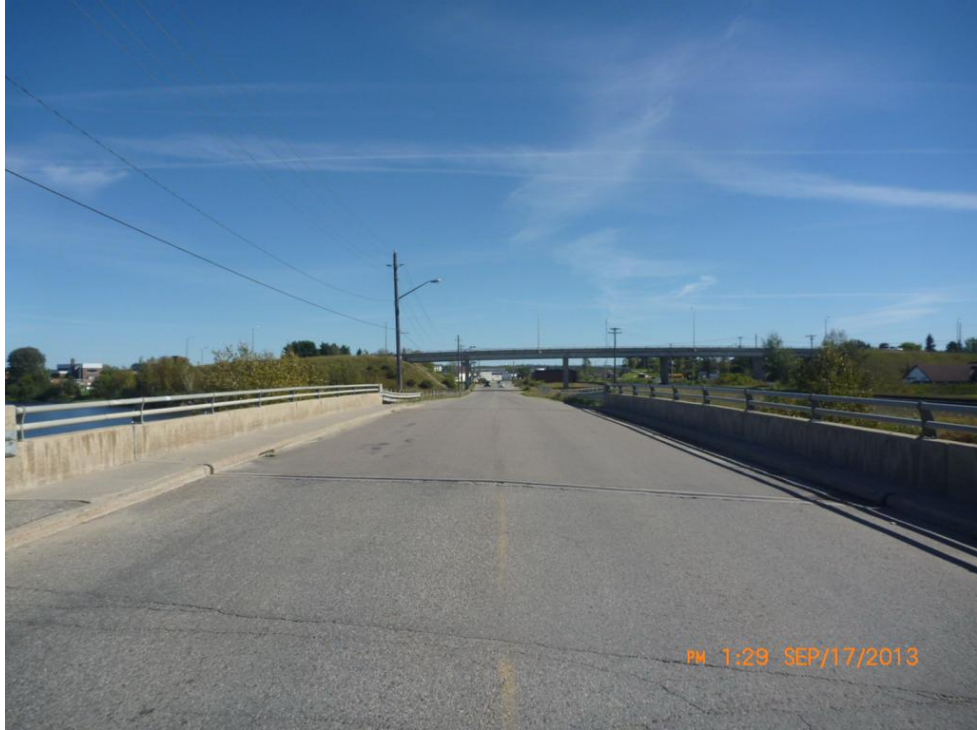
Comments: LOOKING SOUTH OVER STRUCTURE

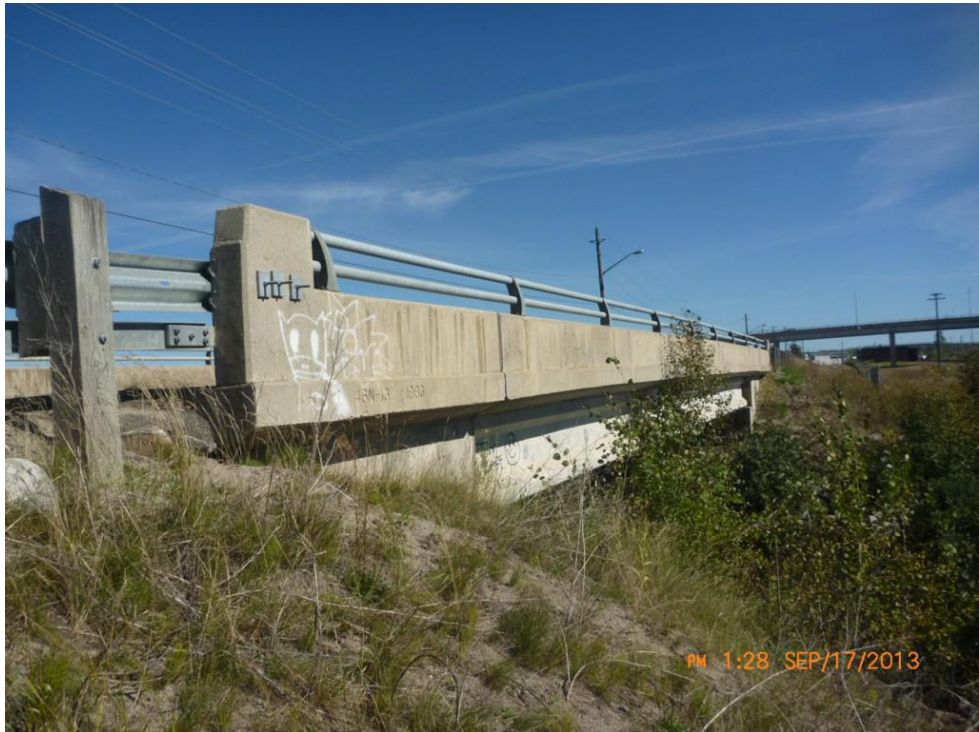
Comments: WEST ELEVATION

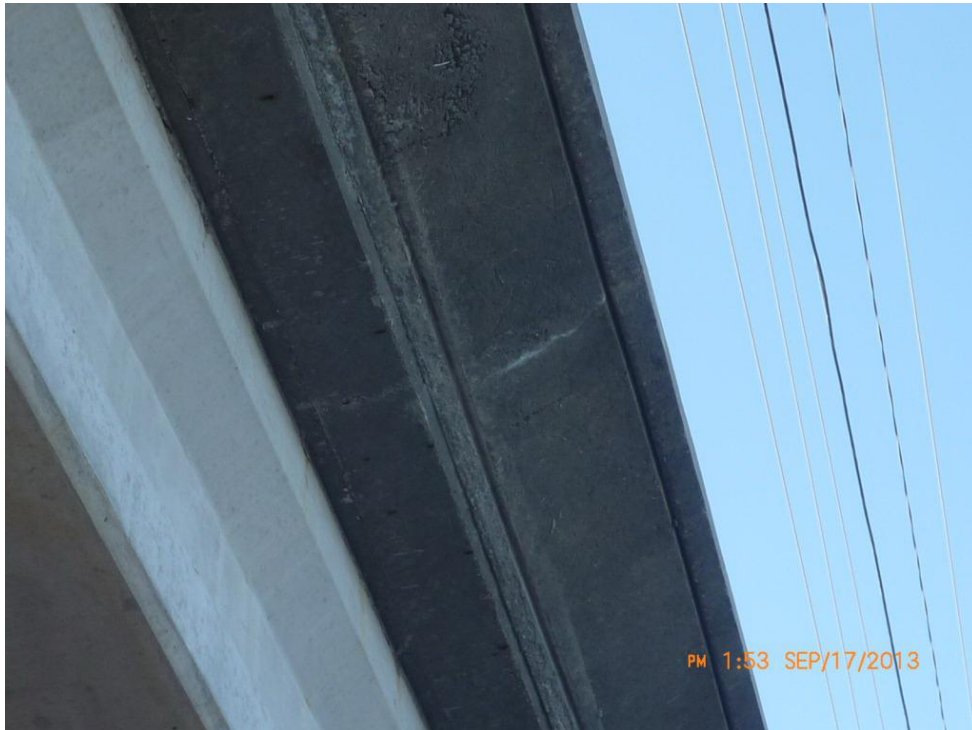
Comments: NARROW STAINED CRACK ON EXTERIOR SOFFIT

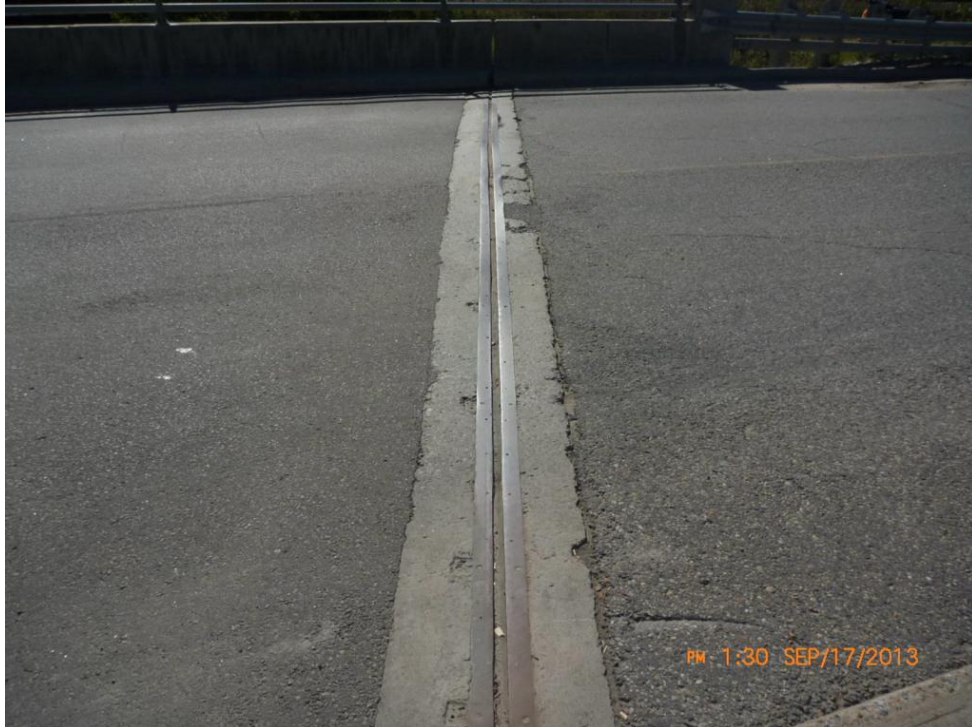
Comments: NORTH EXPANSION JOINT

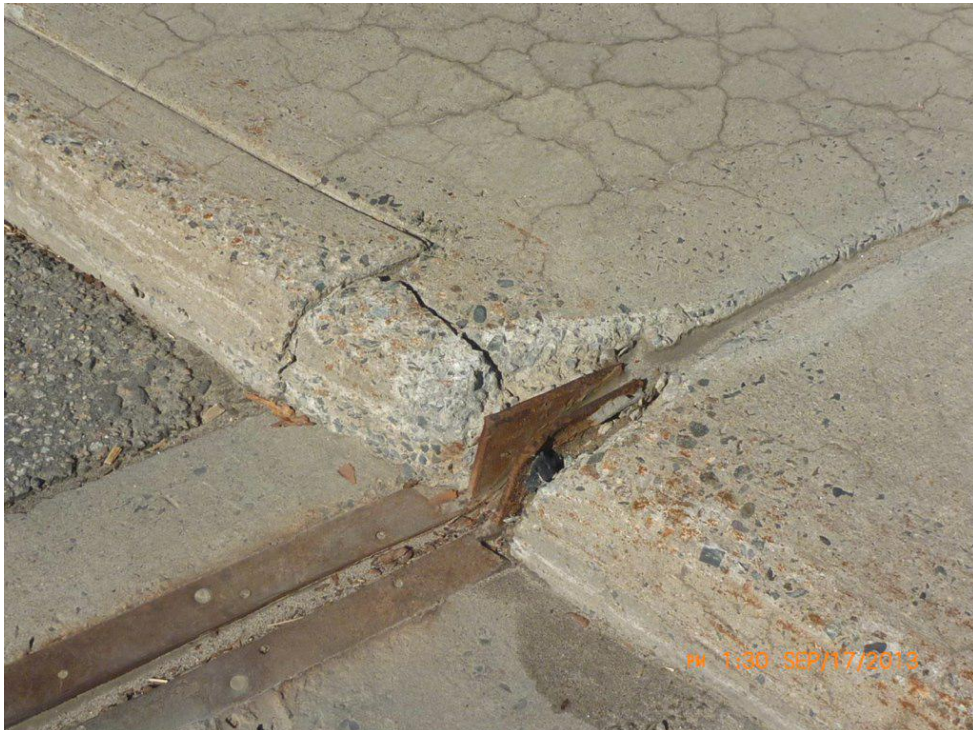
Comments: SPALL ON CURB

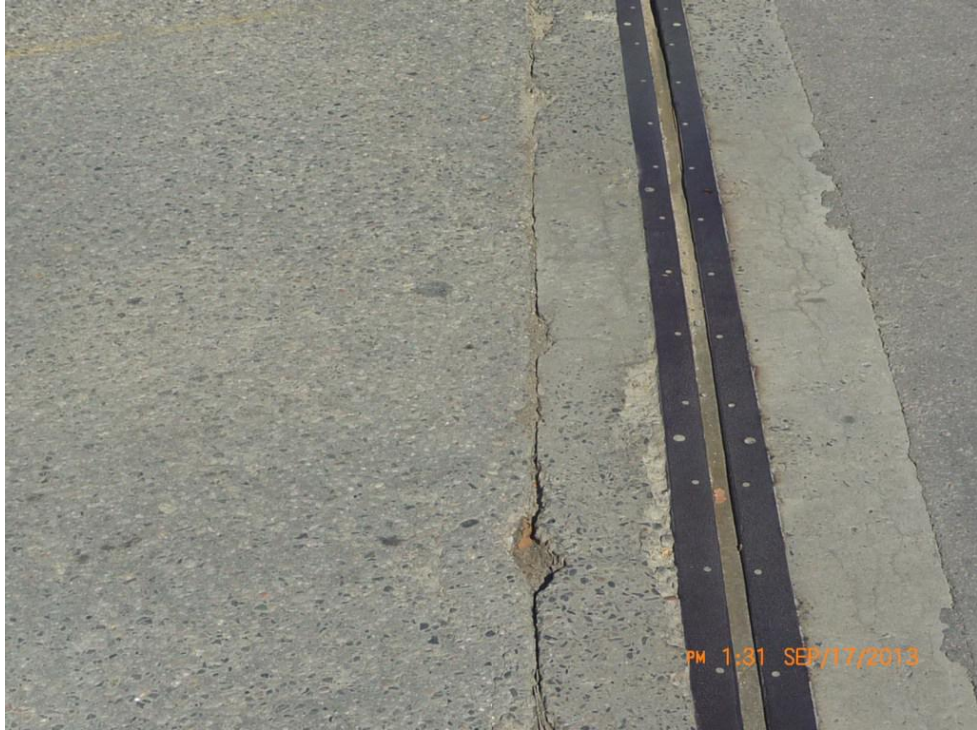
Comments: GAP BETWEEN APPROACH SURFACE AND JOINT
Path: E:\WorkTech Data\Chapleau\Photos\2013\Photo 055.JPG

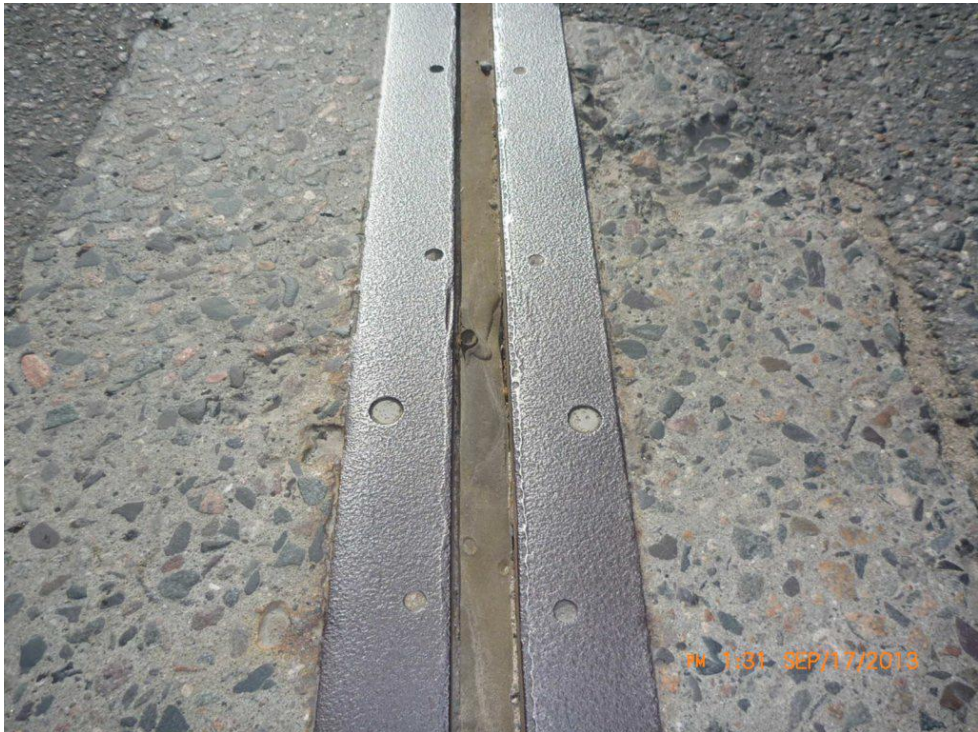
Comments: SEPARATION OF JOINT SEAL FROM ARMORING ANGLE
Path: E:\WorkTech Data\Chapleau\Photos\2013\Photo 056.JPG

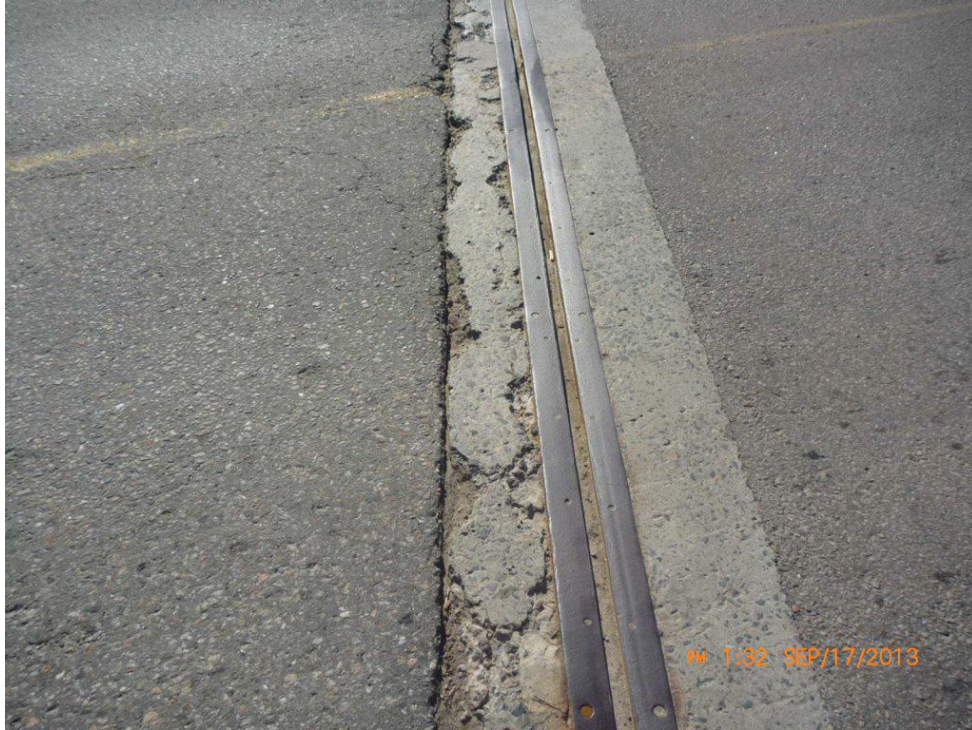
Comments: SEVERE SPALLING OF SOUTH JOINT END DAM

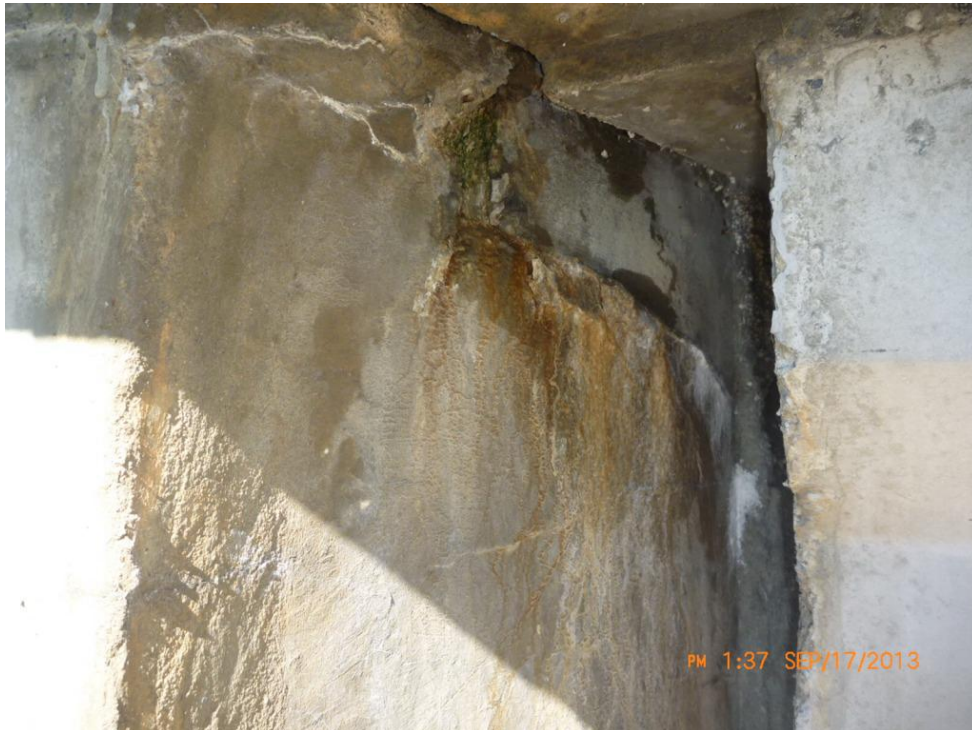
Comments: EFFLORESCENCE ON BALLAST WALL

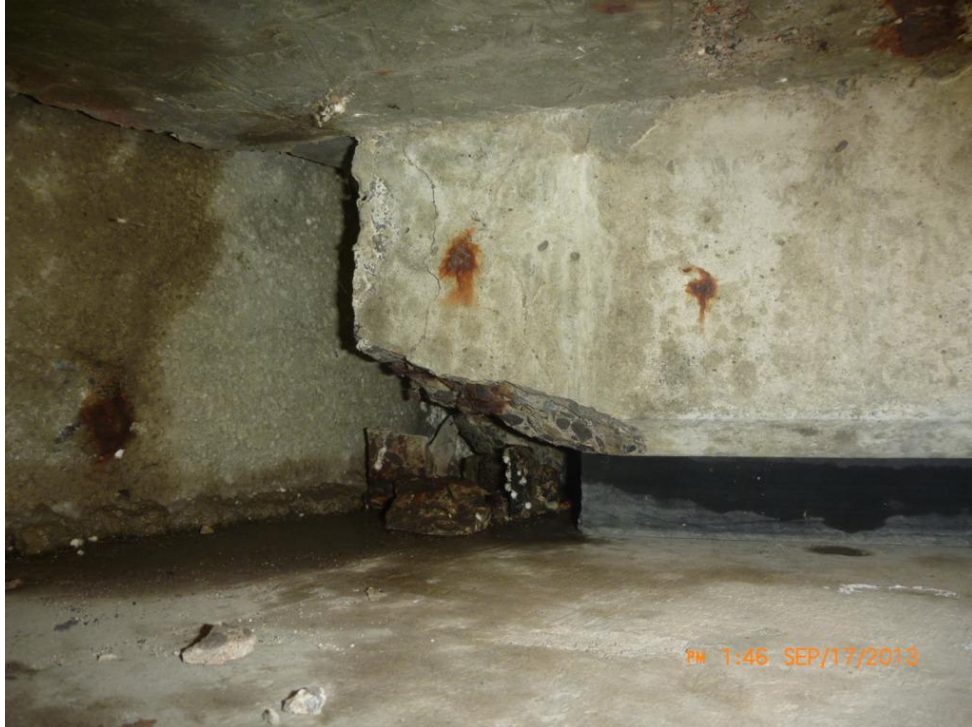
Comments: SPALL AND DELAMINATION ON GIRDER END

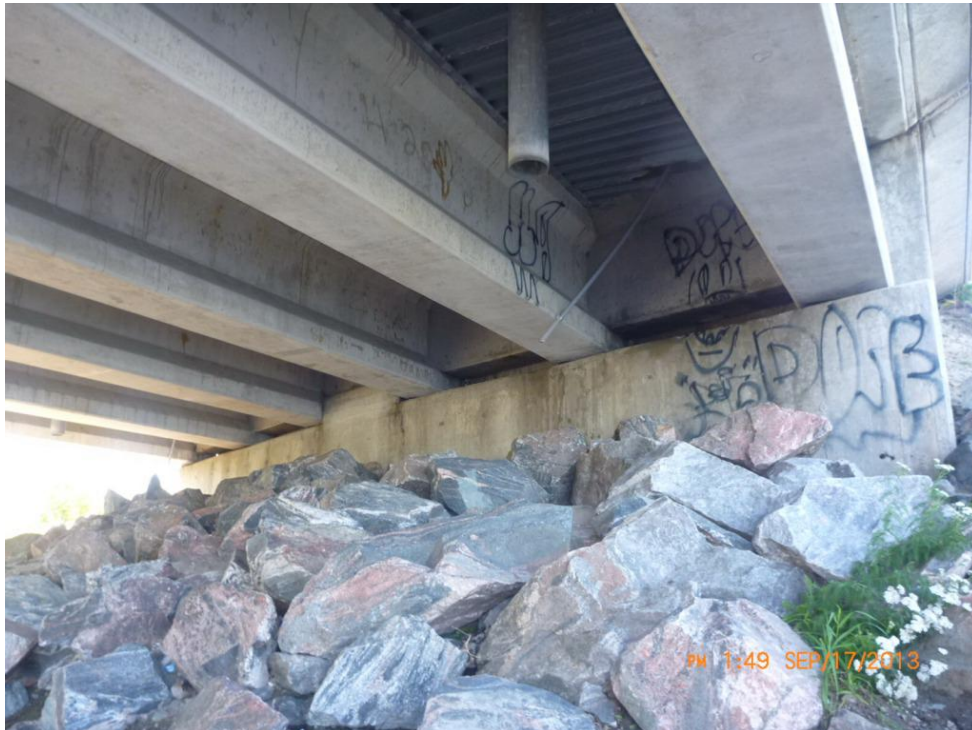
Comments: NORTH ABUTMENT

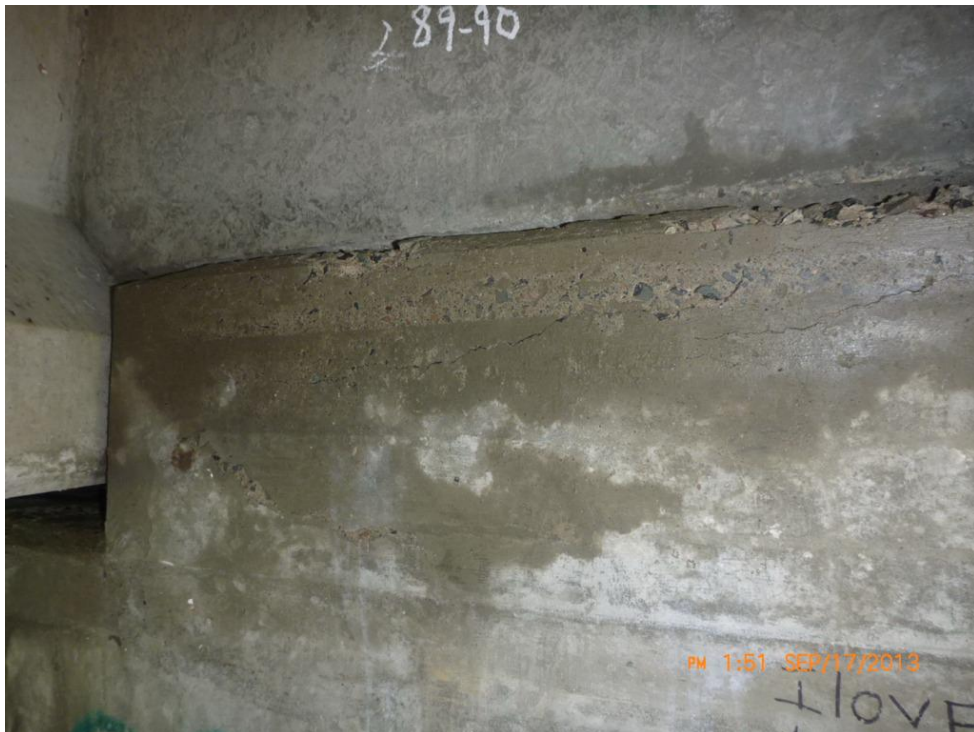
Comments: DELAMINATION ON ABUTMENT WALL

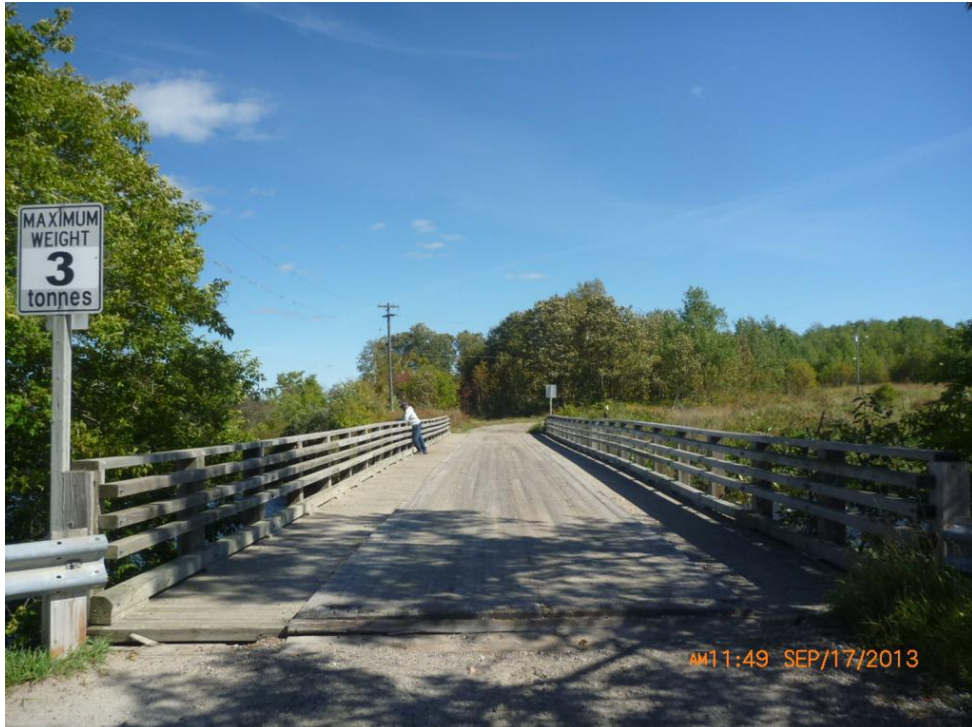
Comments: LOOKING EAST OVER STRUCTURE

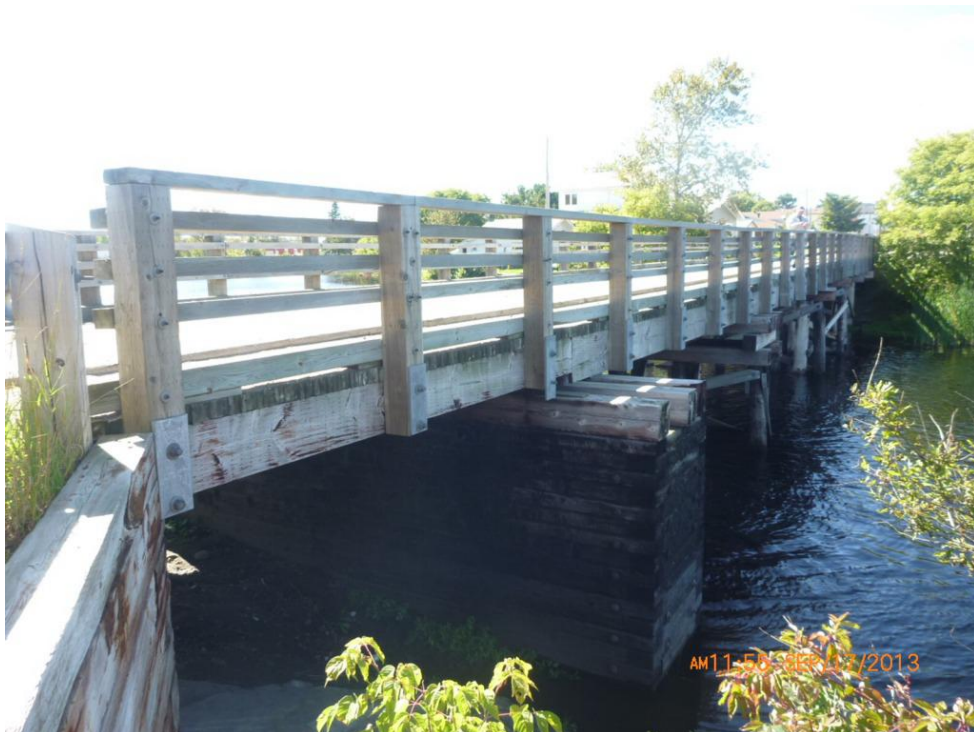
Comments: NORTH ELEVATION
