TOWNSHIP OF CHAPLEAU

MUNICIPAL STRUCTURE INVENTORY AND INSPECTION - 2013

AECOM

December, 2013

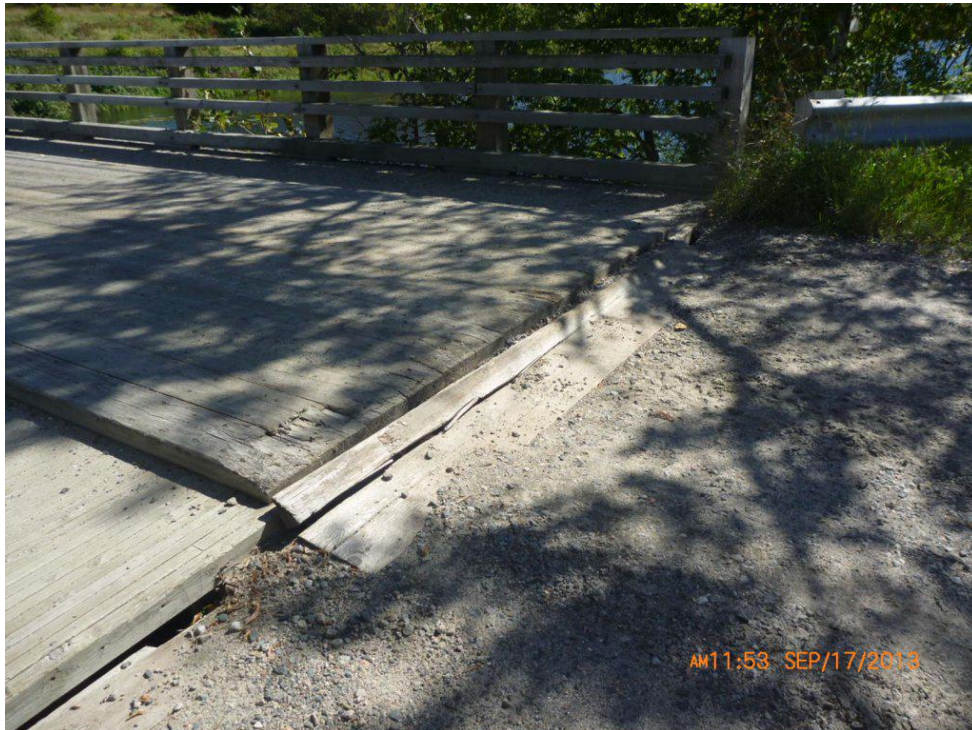
Comments: MISSING GRANULAR MATERIAL AT WEST APPROACH

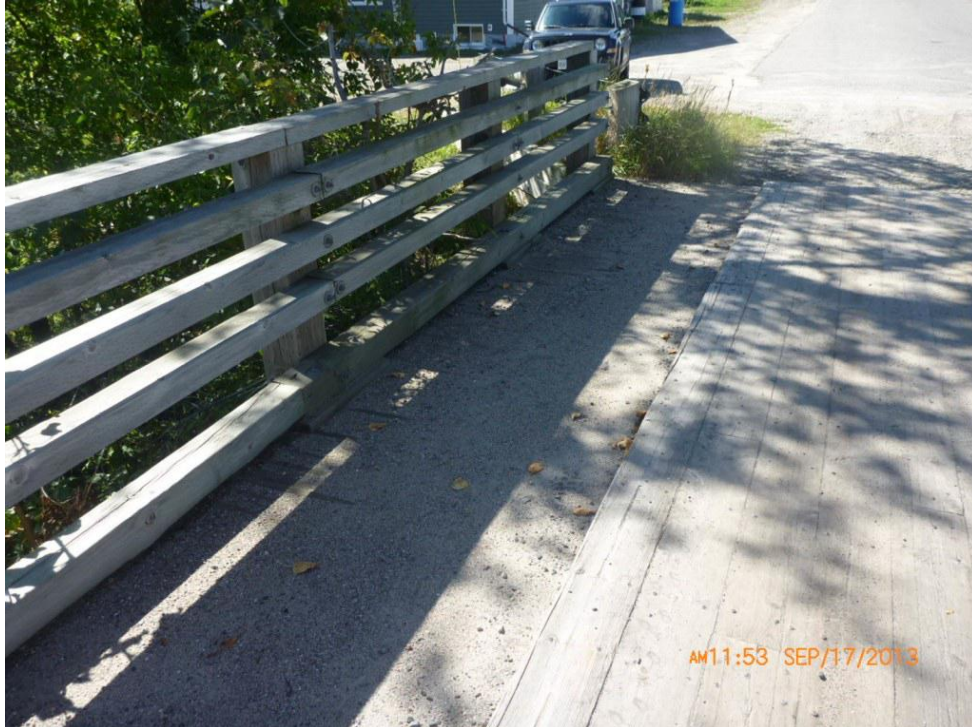
Comments: TYPICAL DECK TOP WITH DEBRIS

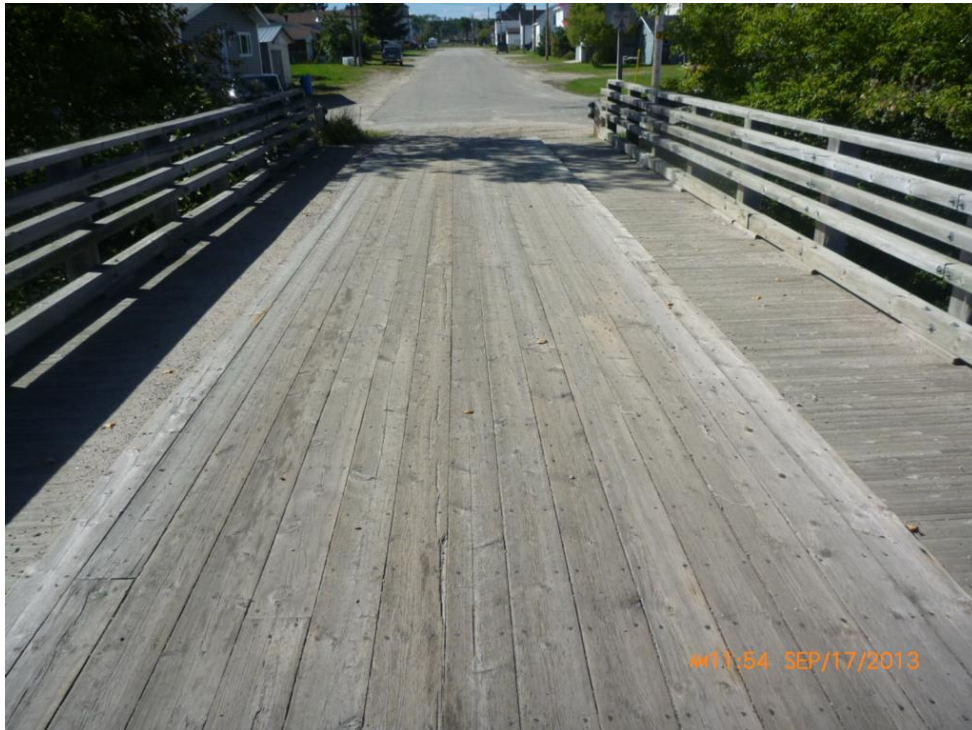
Comments: TYPICAL WEARING SURFACE

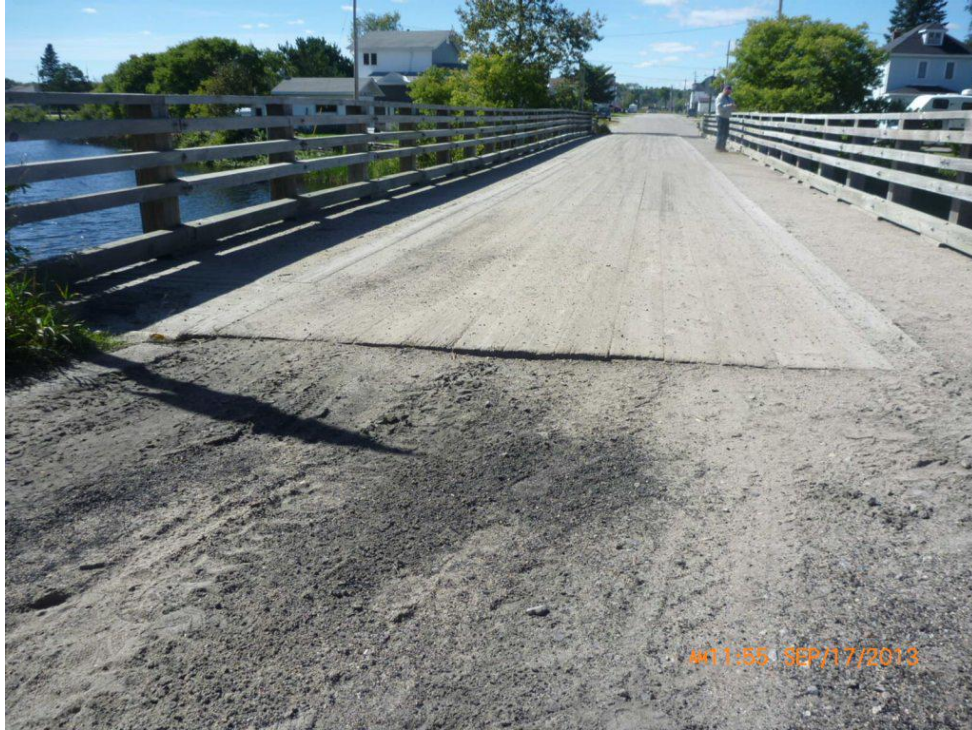
Comments: MISSING GRANULAR MATERIAL AT EAST APPROACH

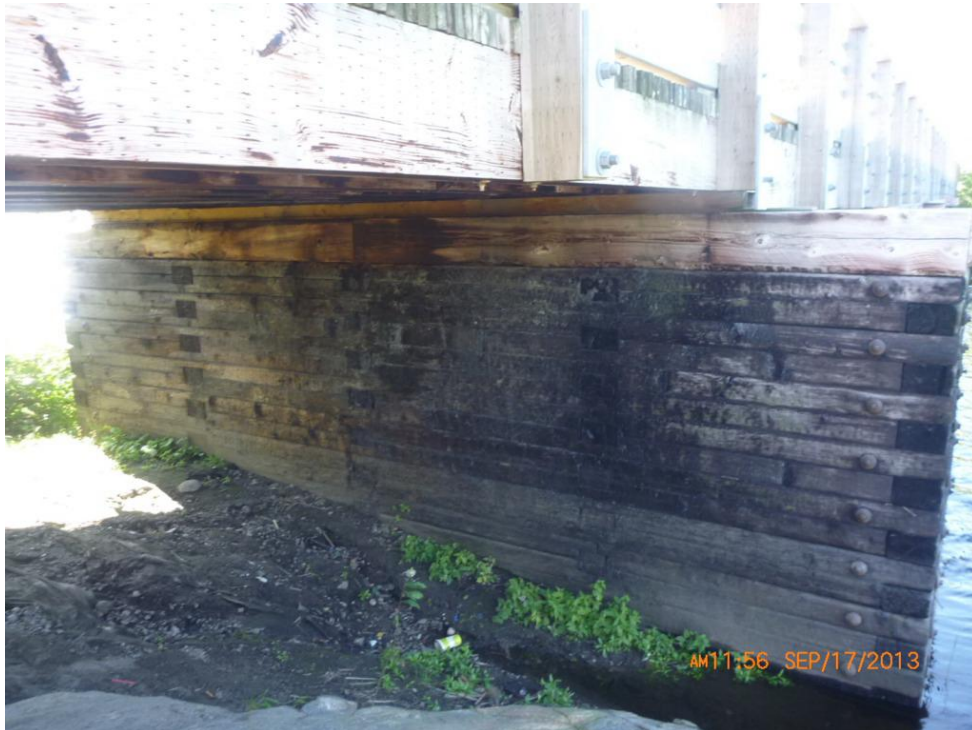
Comments: TYPICAL PIER WITH SHEETING

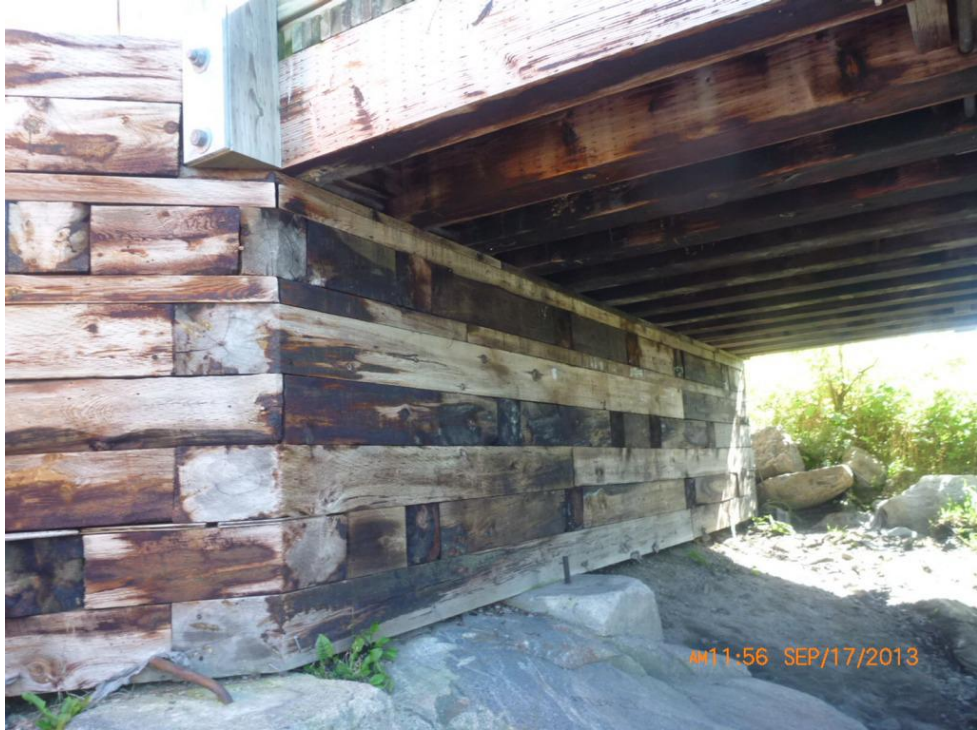
Comments: EAST ABUTMENT WALL

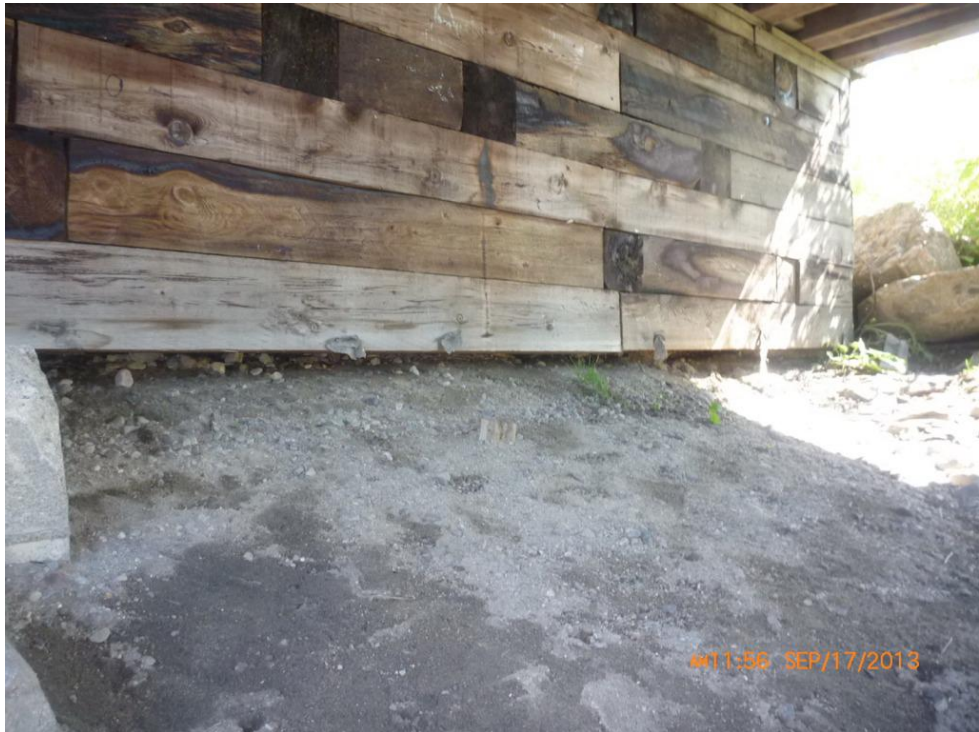
Comments: UNDERMINING OF EAST ABUTMENT WALL

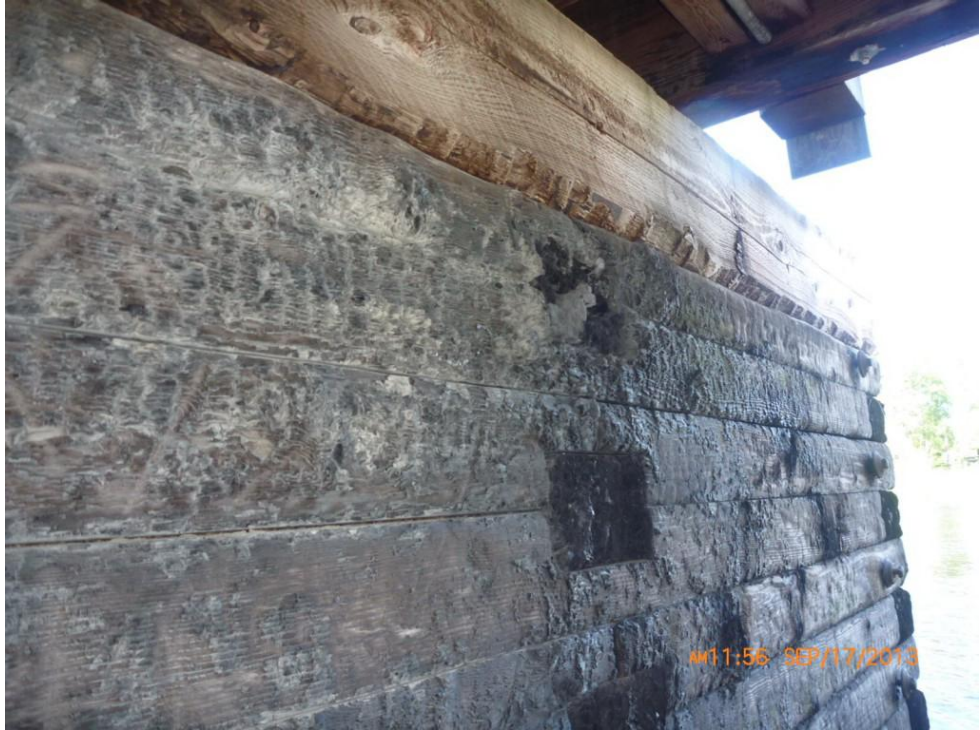
Comments: FIRE DAMAGE ON EAST PIER SHEETING

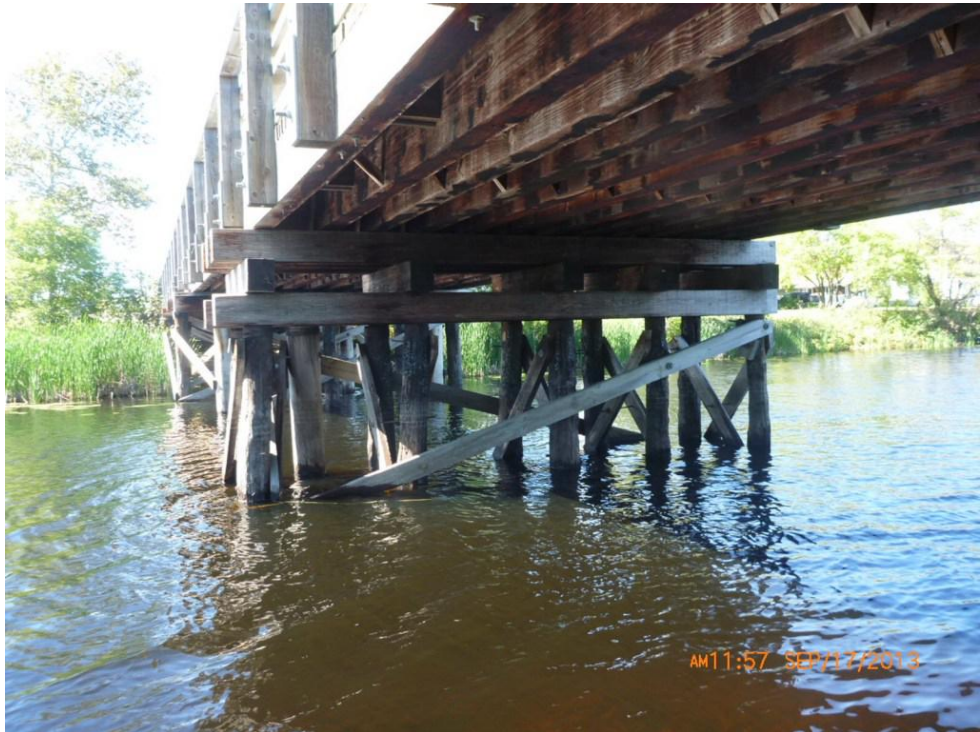
Comments: TYPICAL PIER WITH SHEETING

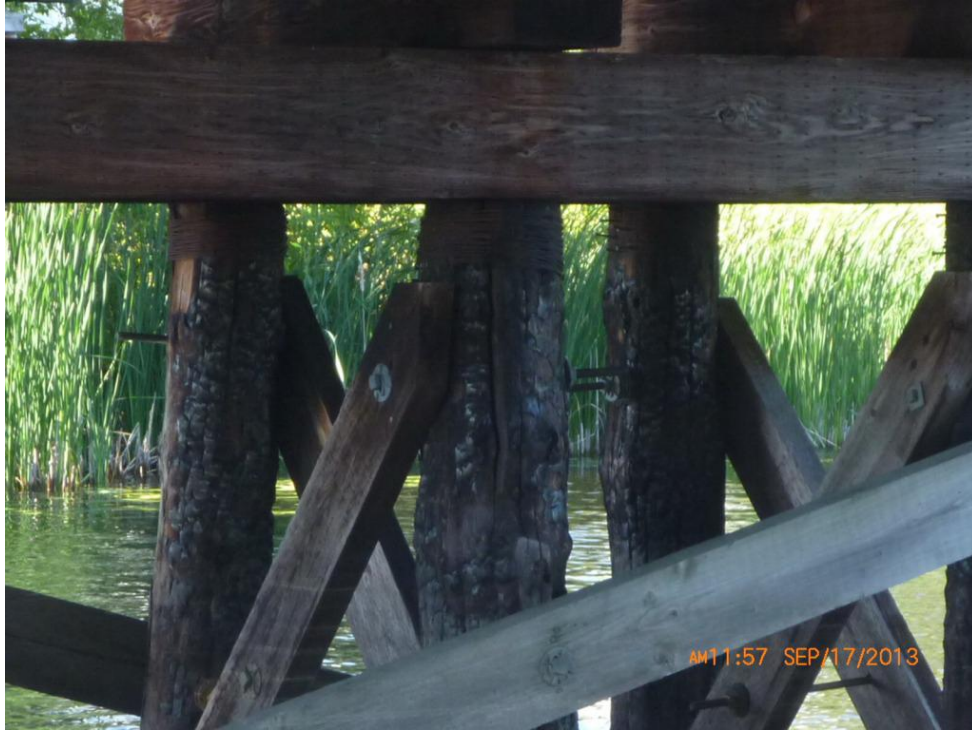
Comments: SEVERE SPLIT AND FIRE DAMAGE TO PIER PILE
Path: E:\WorkTech Data\Chapleau\Photos\2013\Photo 012.JPG

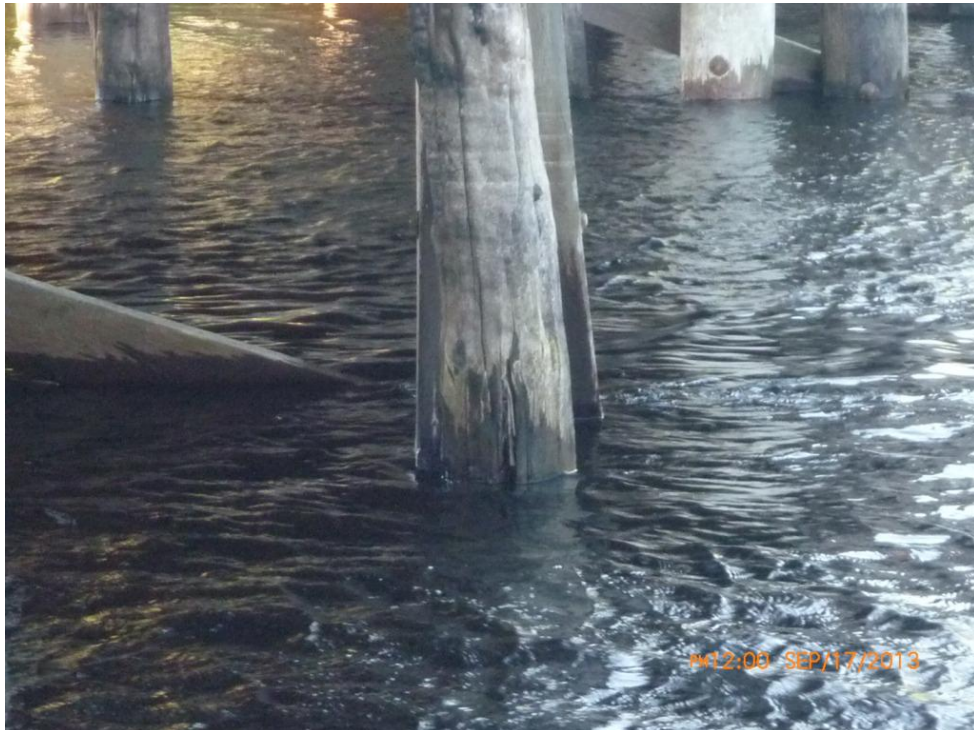
Comments: SEVERE CENTER ROT OF PIER PILE
Path: E:\WorkTech Data\Chapleau\Photos\2013\Photo 013.JPG

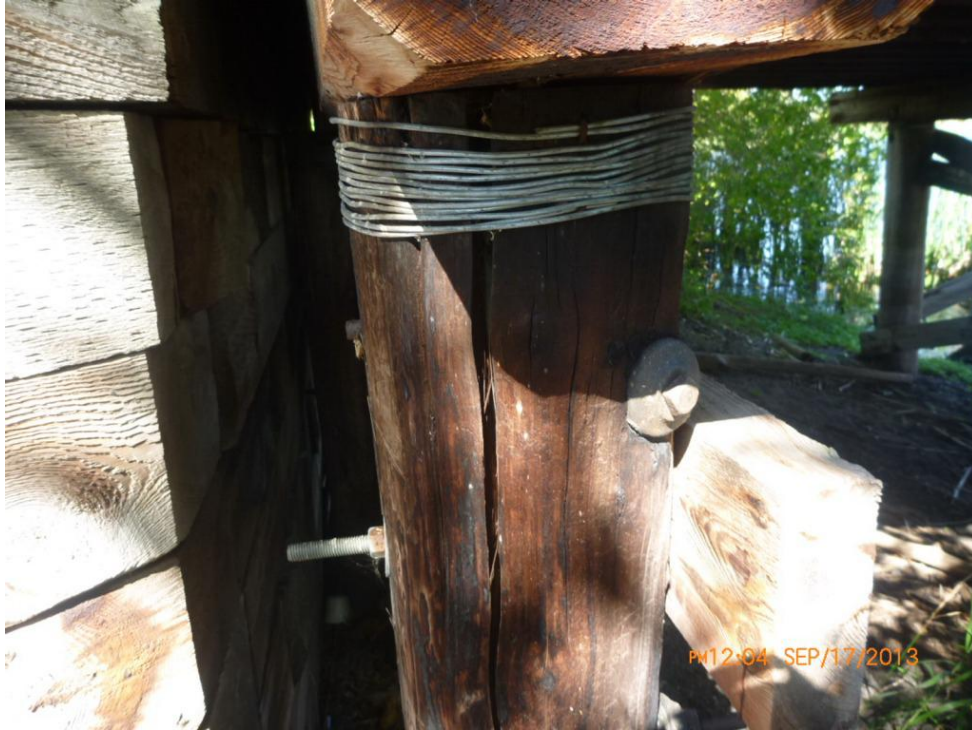
Comments: SEVERE SPLITTING OF WEST ABUTMENT PILE
Path: E:\WorkTech Data\Chapleau\Photos\2013\Photo 014.JPG

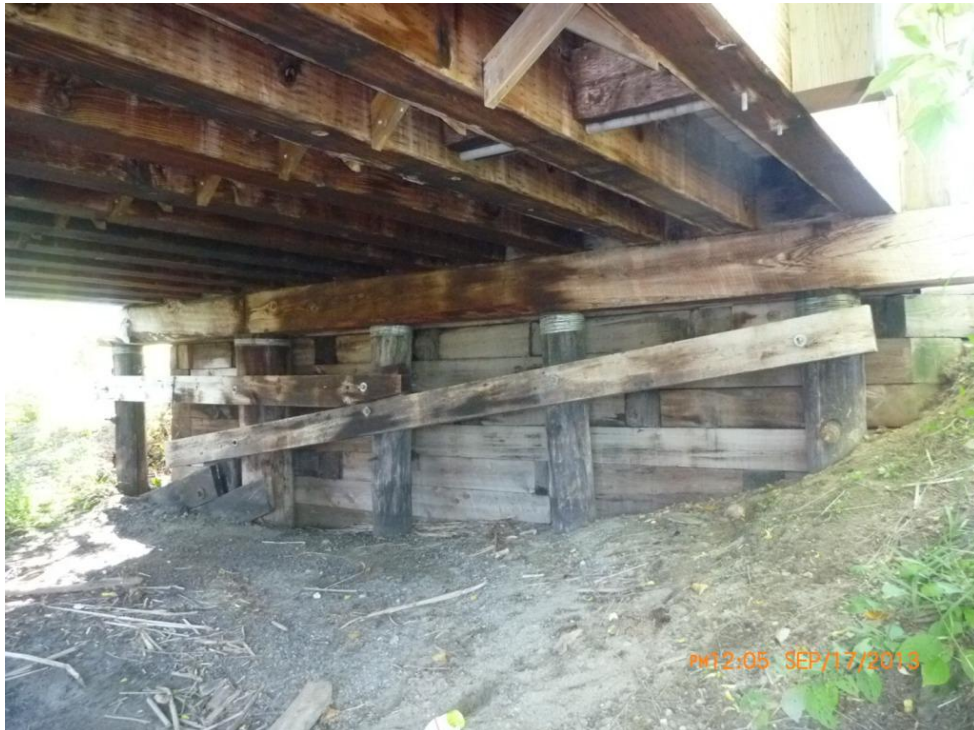
Comments: WEST ABUTMENT WALL
Path: E:\WorkTech Data\Chapleau\Photos\2013\Photo 015.JPG

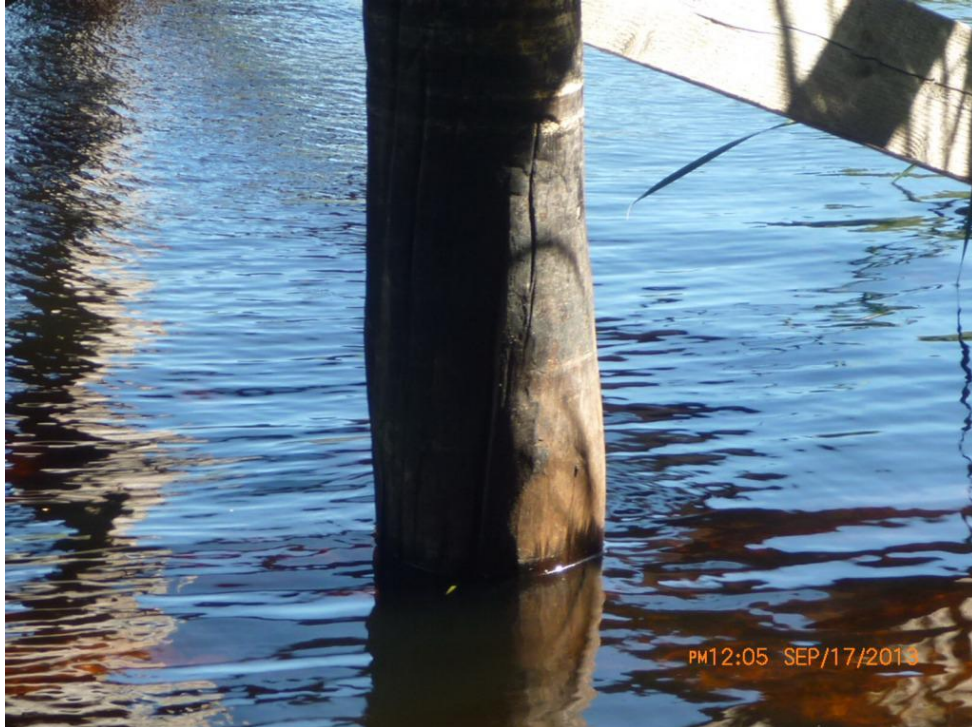
Comments: SEVERE SPLITTING AND CENTER ROT ON PIER PILE

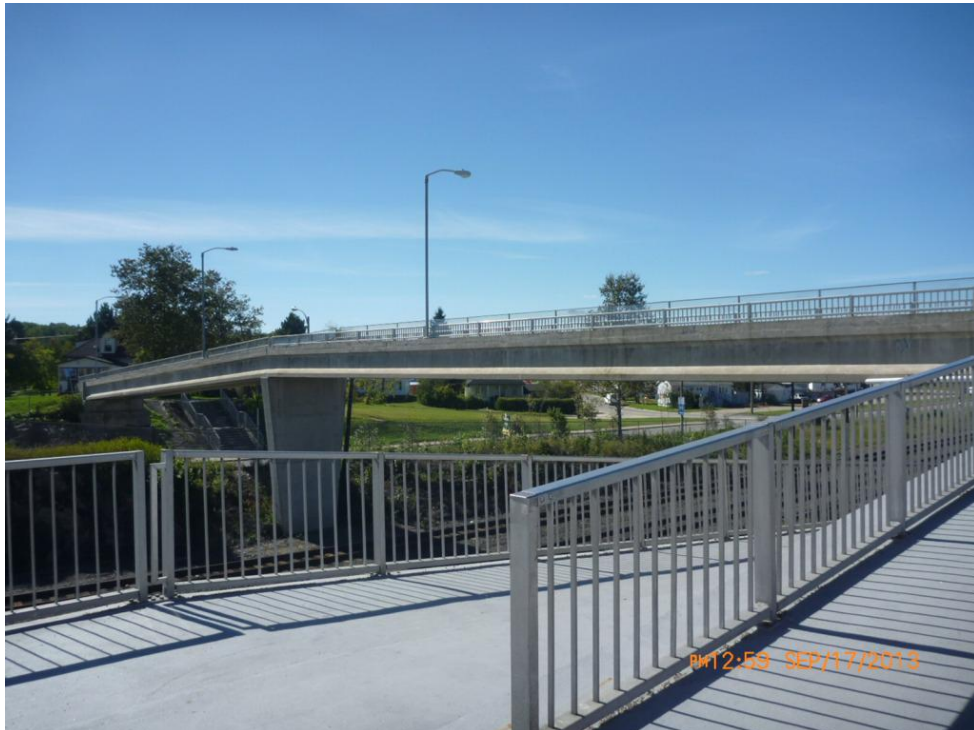
Comments: SOUTH ELEVATION

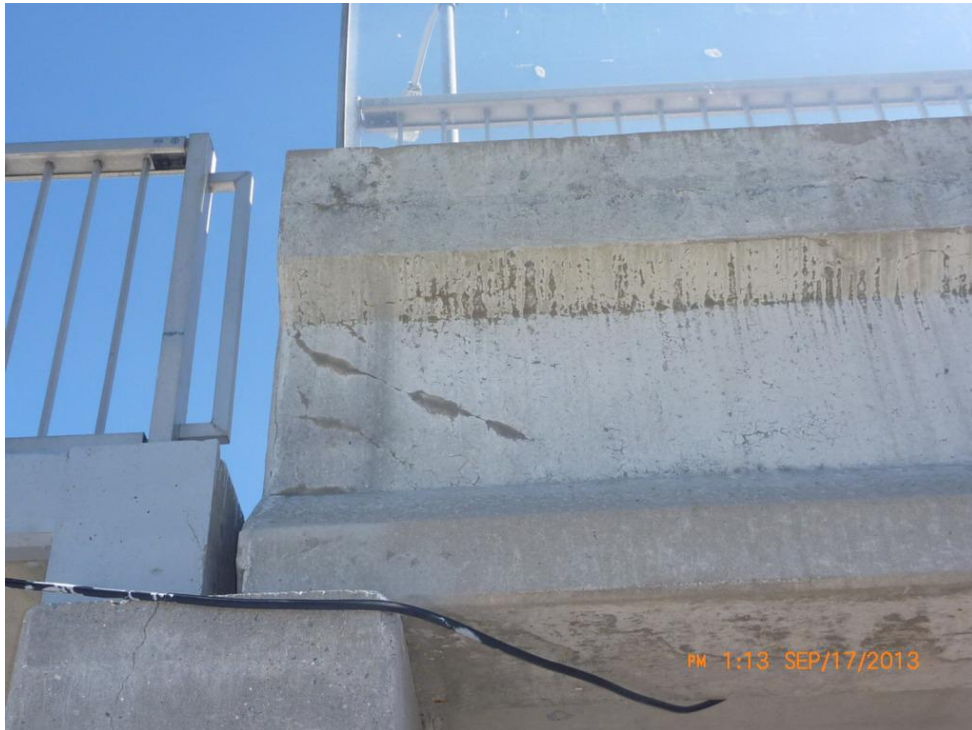
Comments: DIAGONAL CRACKING ON GIRDER END AT EAST ABUTMENT
Path: E:\WorkTech Data\Chapleau\Photos\2013\Photo 049.JPG

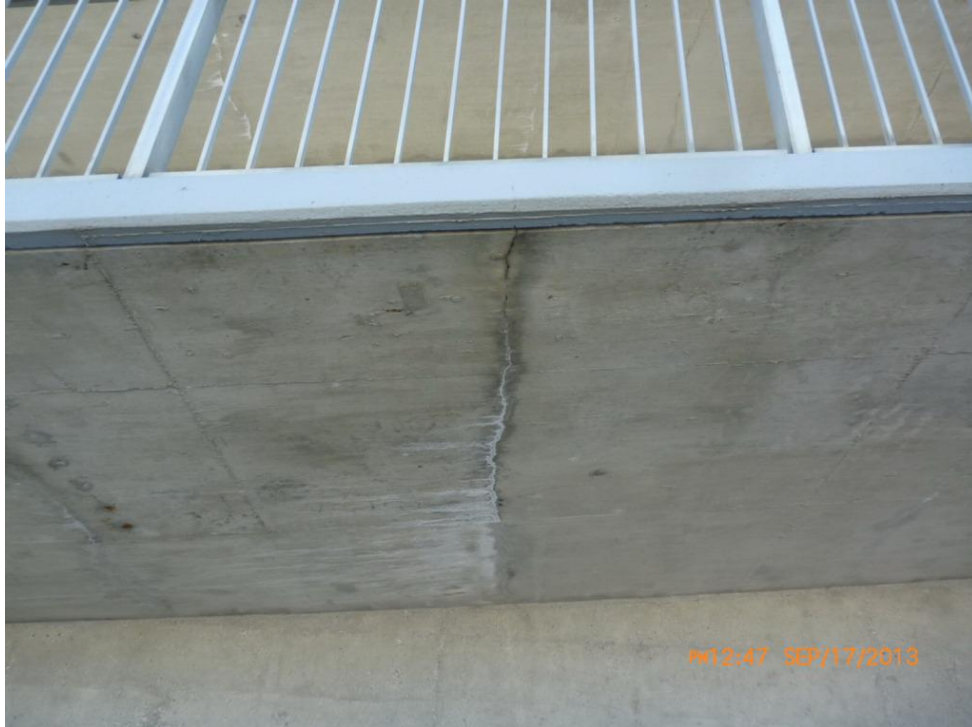
Comments: NARROW STAINED CRACK ON PEDESTRIAN WALKWAY SOFFIT

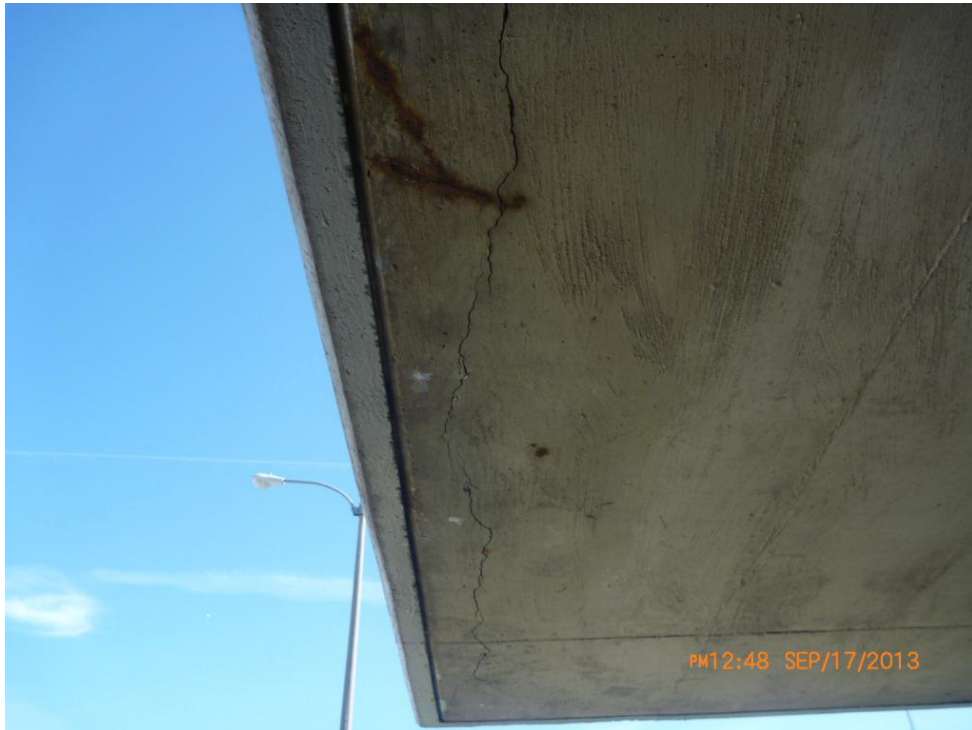
Comments: WIDE CRACK ON PEDESTRIAN WALKWAY SOFFIT

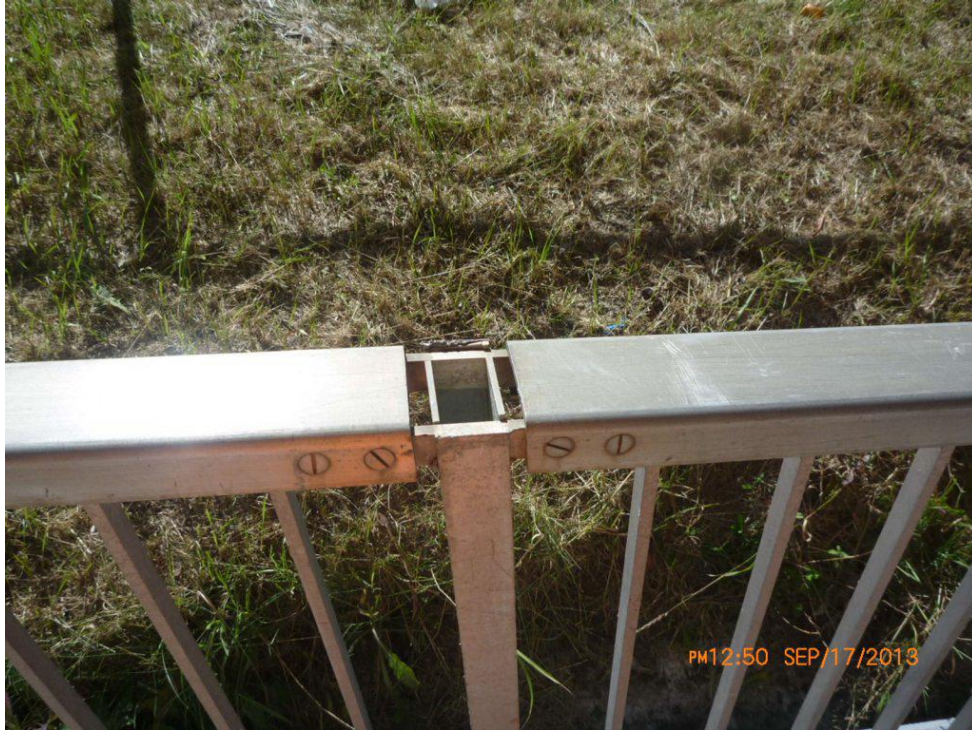
Comments: MISSING HANDRAIL CAP

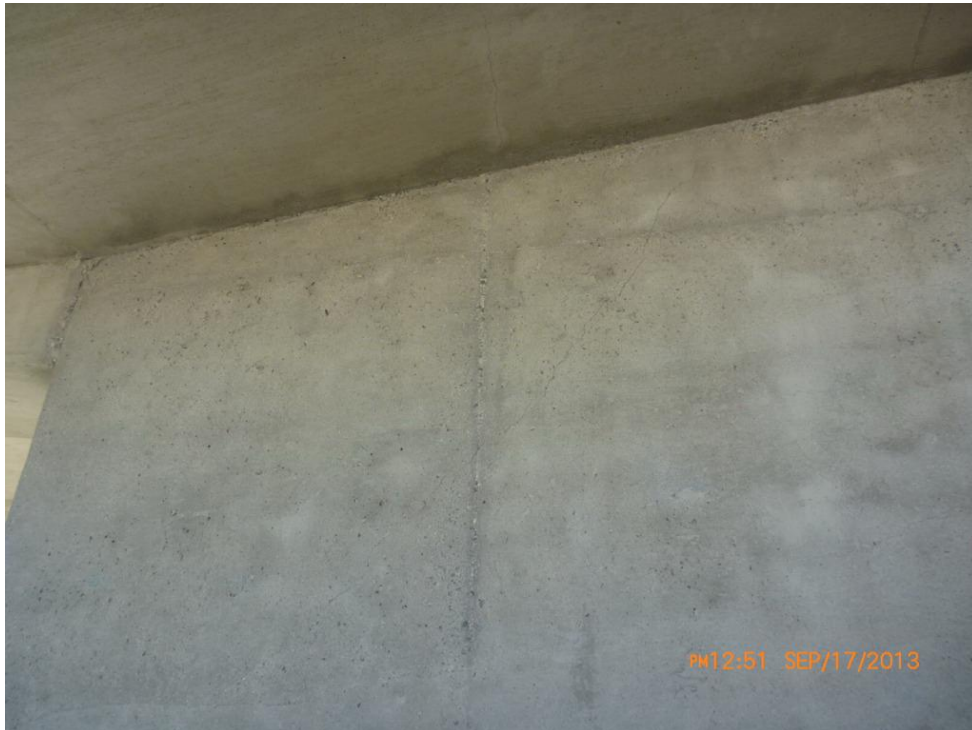
Comments: DIAGONAL CRACK ON ABUTMENT

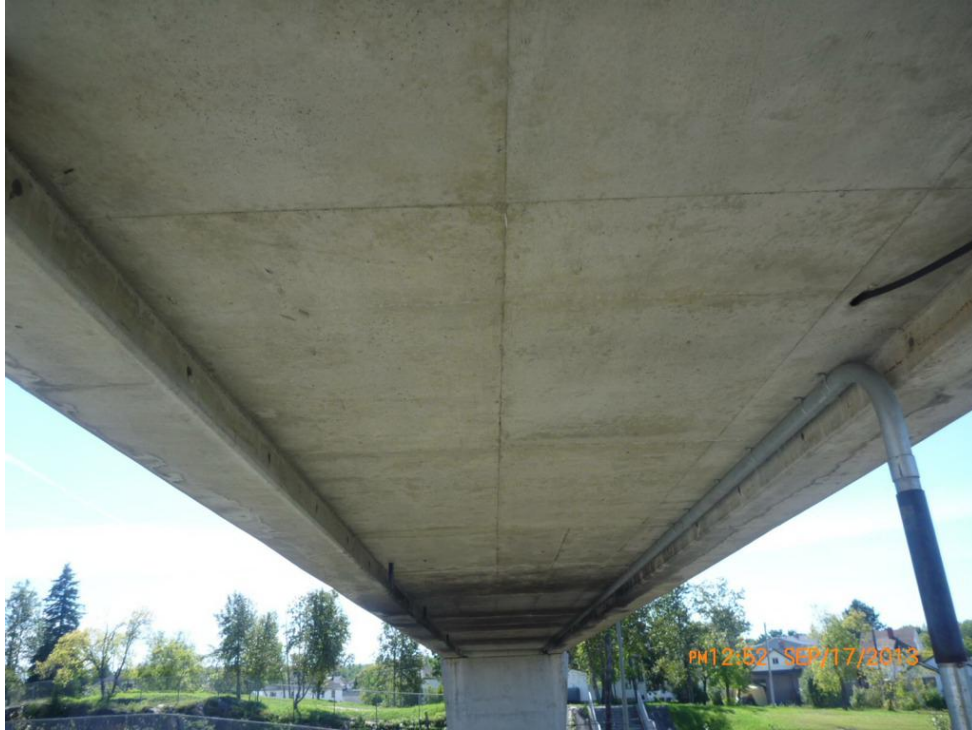
Comments: TYPICAL SOFFIT

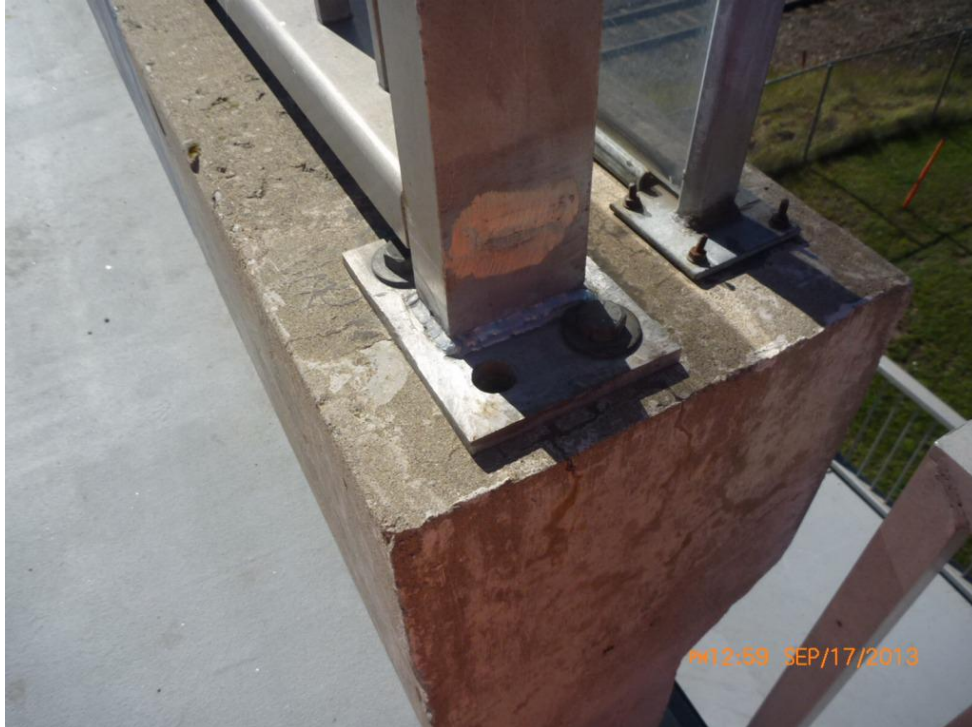
Comments: MISSING HANDRAIL BOLTS

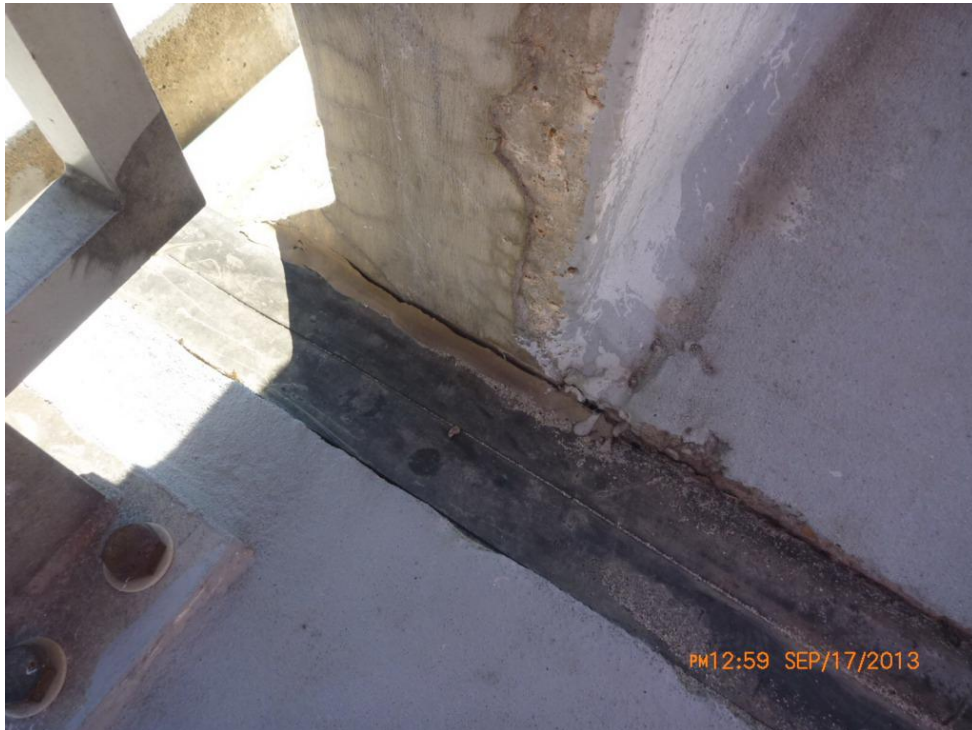
Comments: SEPARATION OF EAST SEAL FROM GIRDER

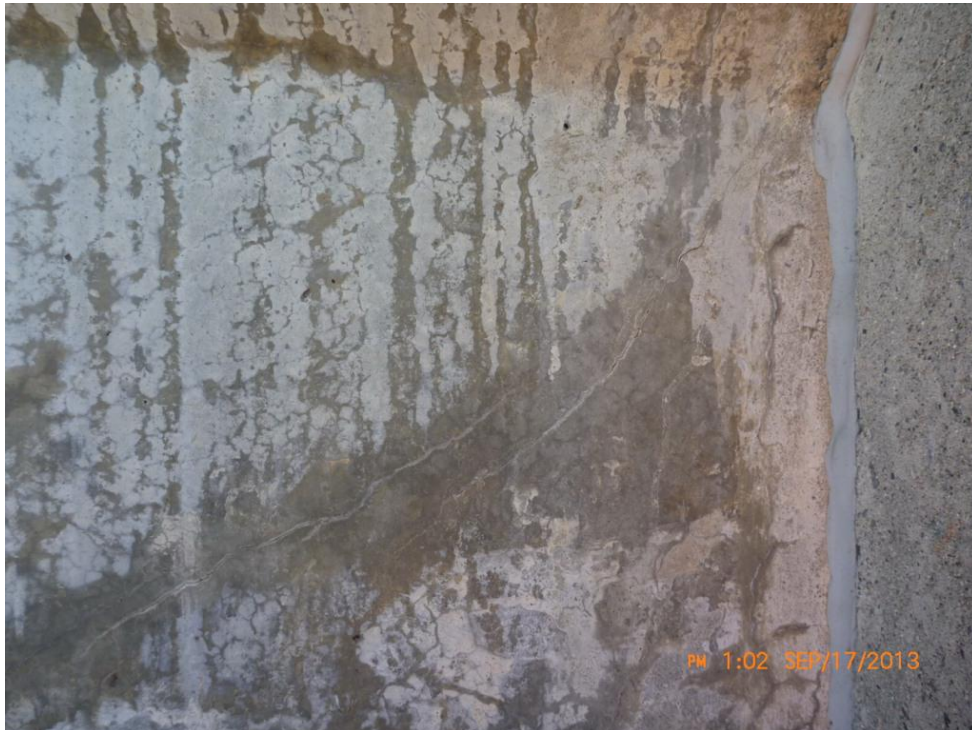
Comments: DIAGONAL CRACKING ON GIRDER END AT WEST ABUTMENT

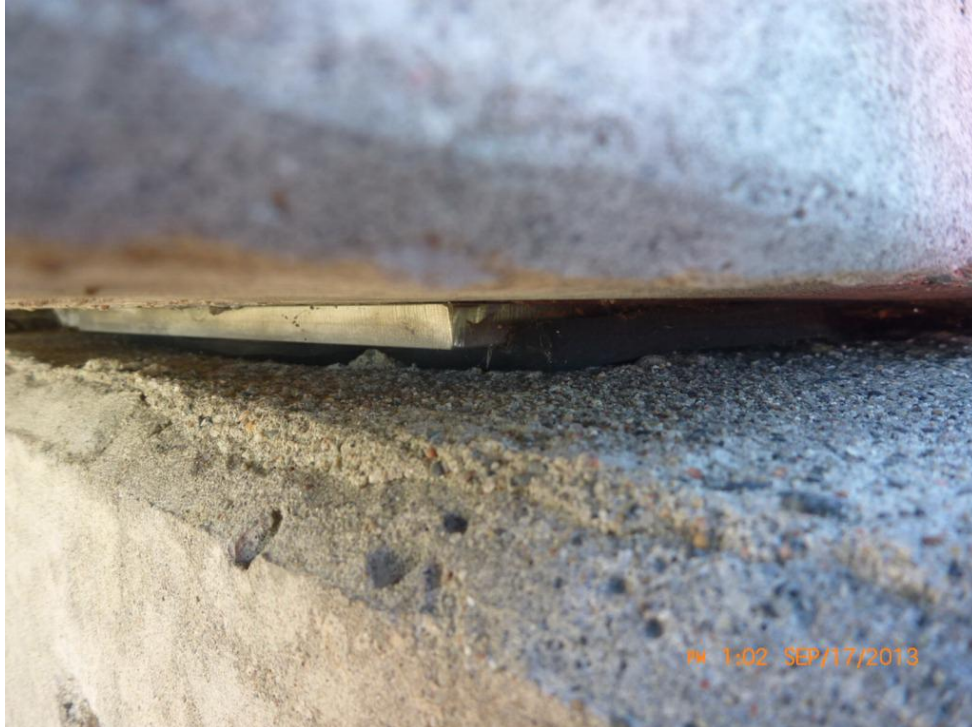
Comments: SQUASHING OF WEST ABUTMENT BEARING

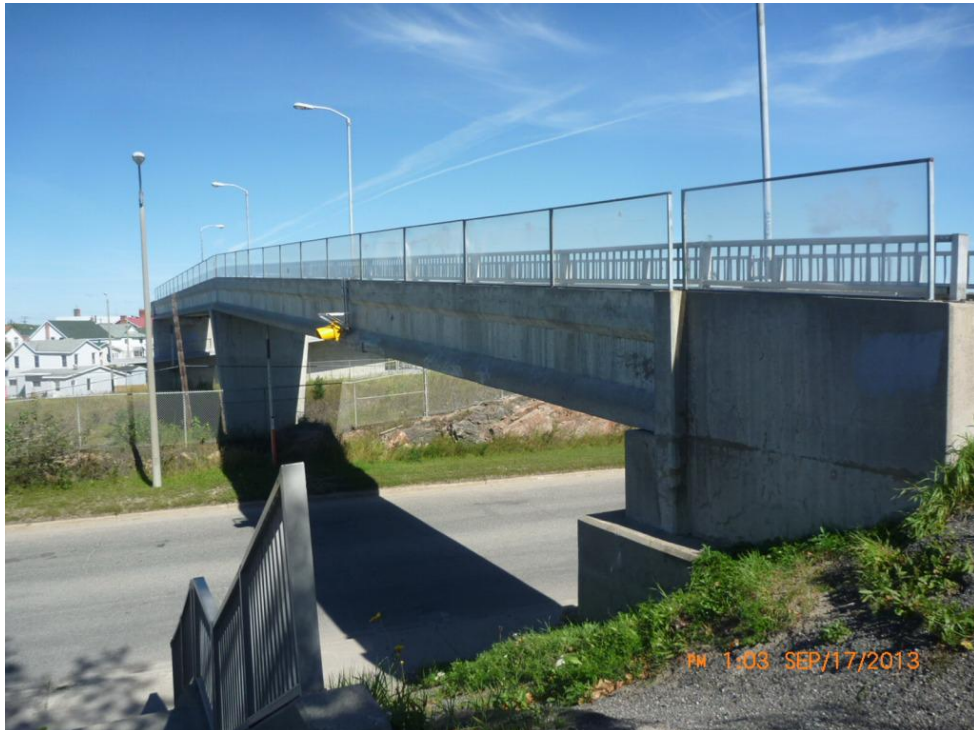
Comments: NORTH ELEVATION

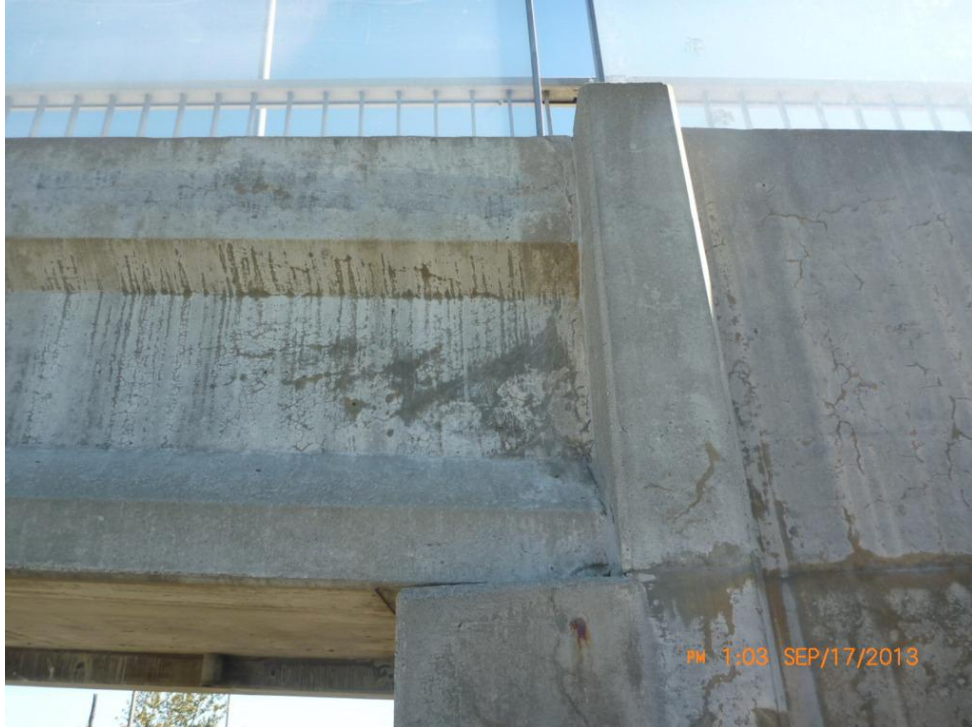
Comments: DIAGONAL CRACKING ON GIRDER END AT WEST ABUTMENT

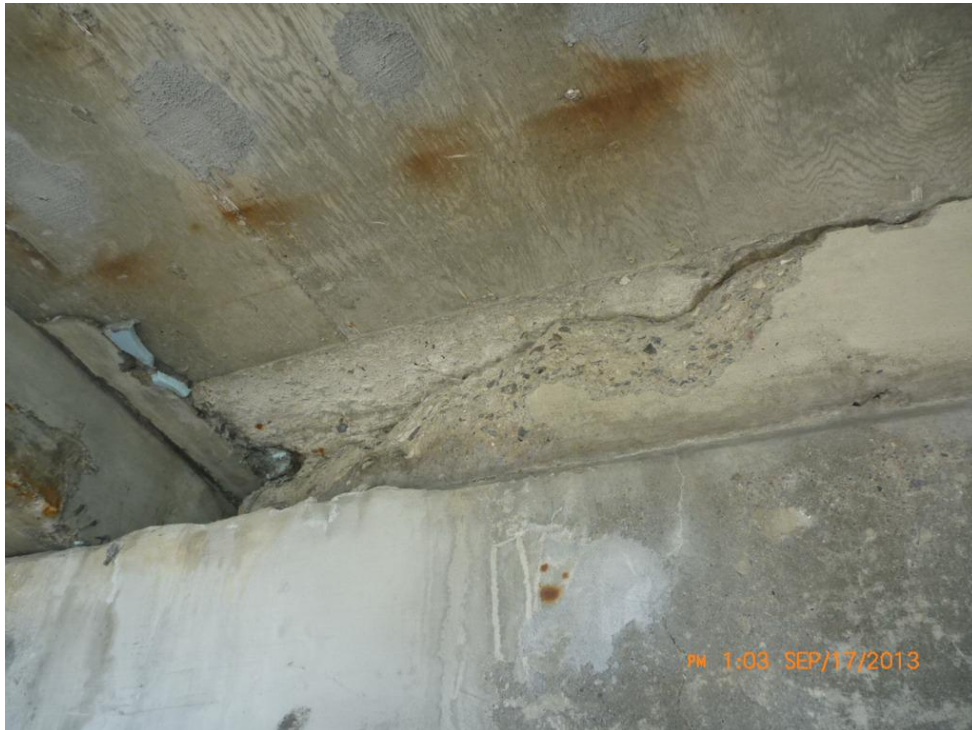
Comments: SPALLING OF ABUTMENT DIAPHRAGM

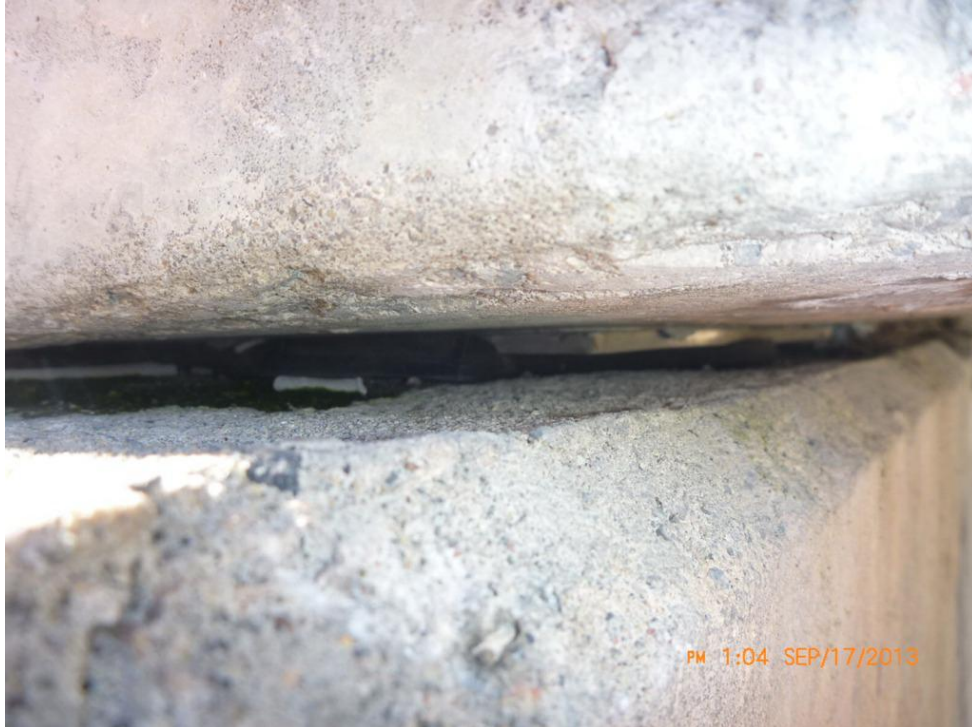
Comments: SQUASHING OF WEST ABUTMENT BEARING

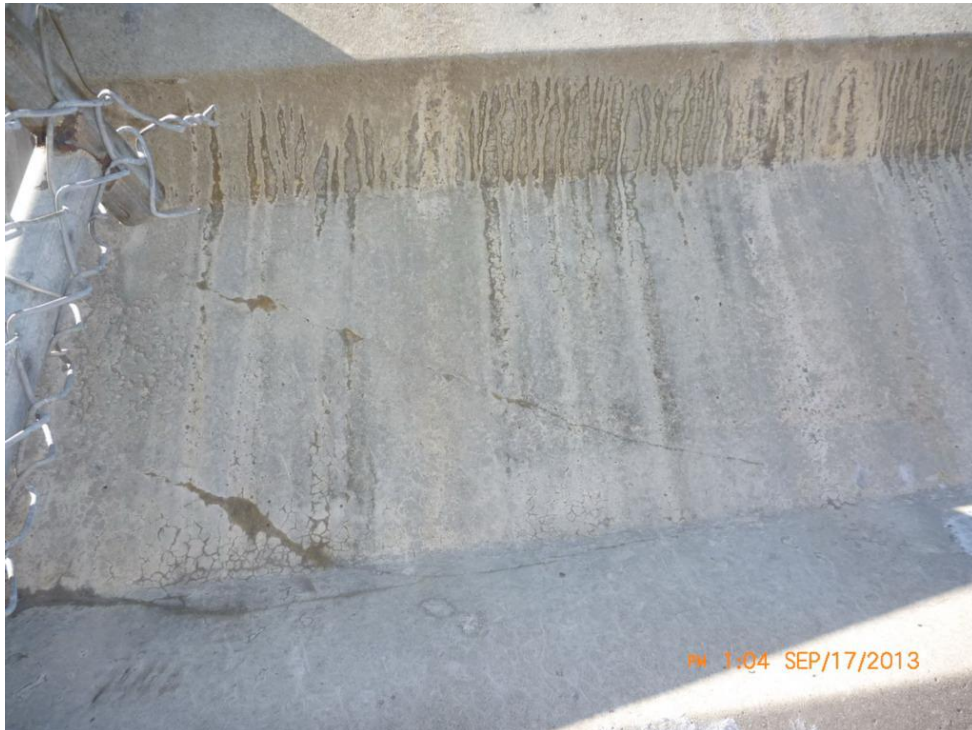
Comments: DIAGONAL CRACKING ON GIRDER END AT WEST ABUTMENT

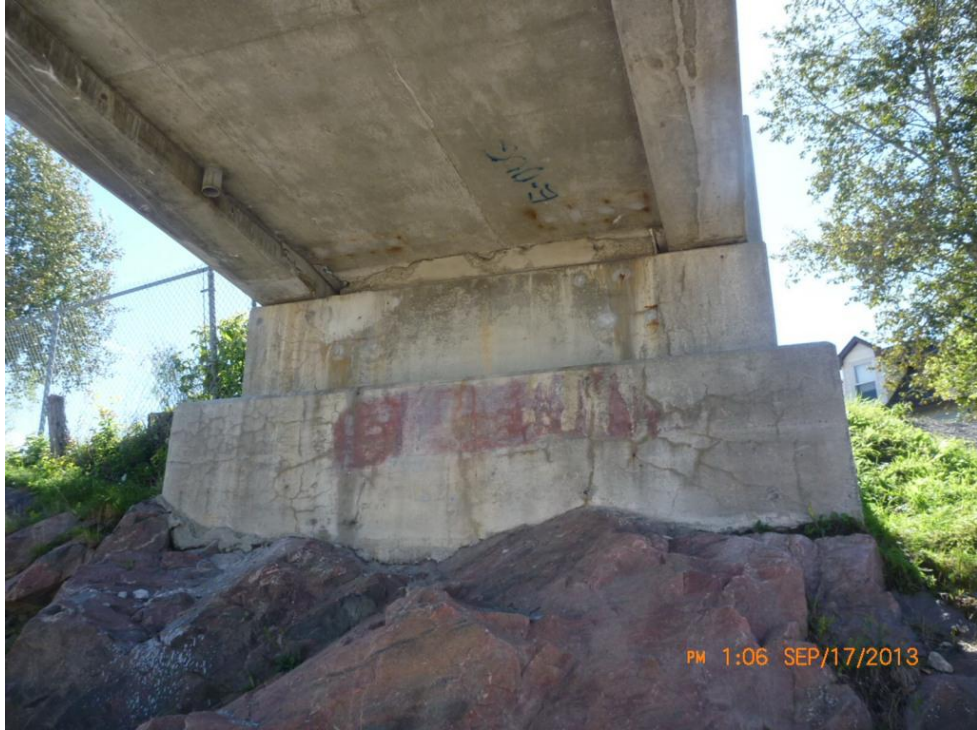
Comments: WEST ABUTMENT WALL

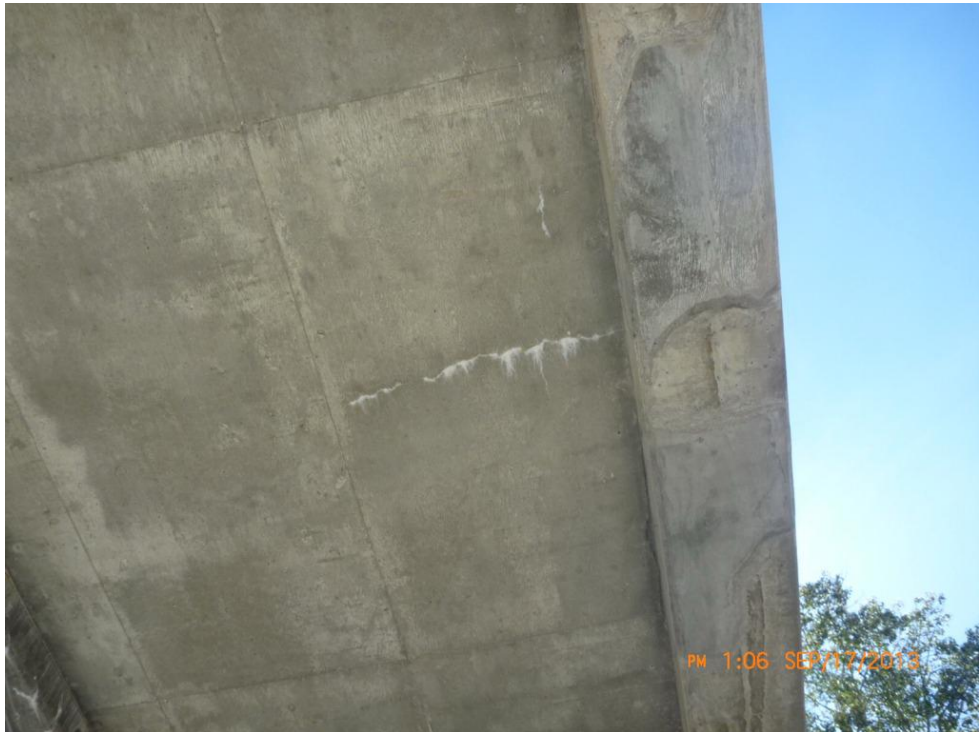
Comments: NARROW STAINED CRACK ON DECK SOFFIT
