TOWNSHIP OF CHAPLEAU

MUNICIPAL STRUCTURE INVENTORY AND INSPECTION - 2013

AECOM

December, 2013

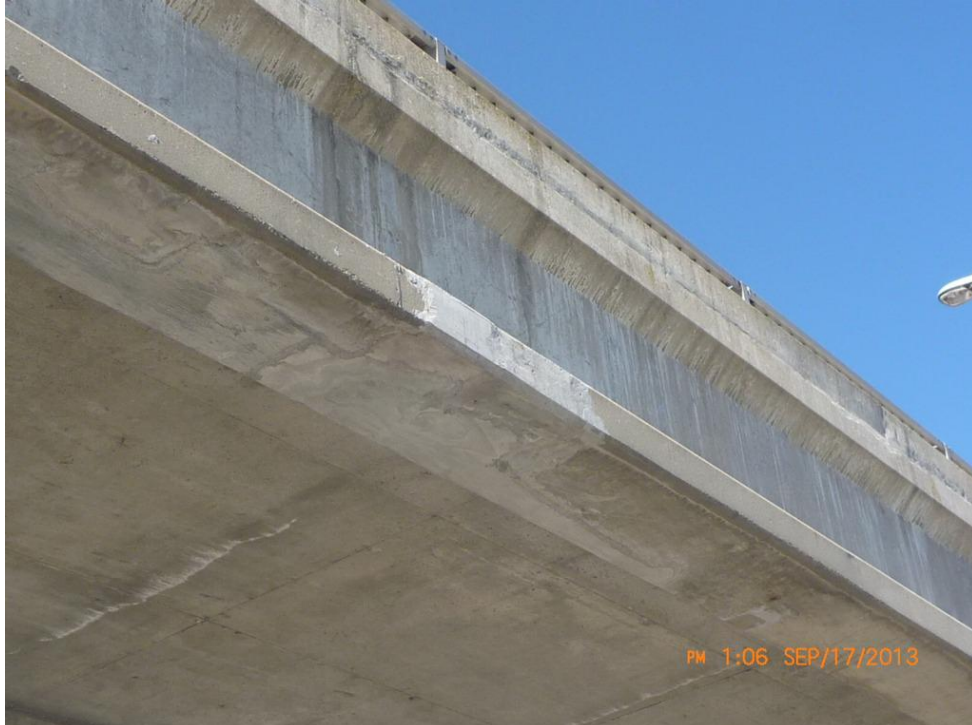
Comments: CONCRETE PATCH ON GIRDER

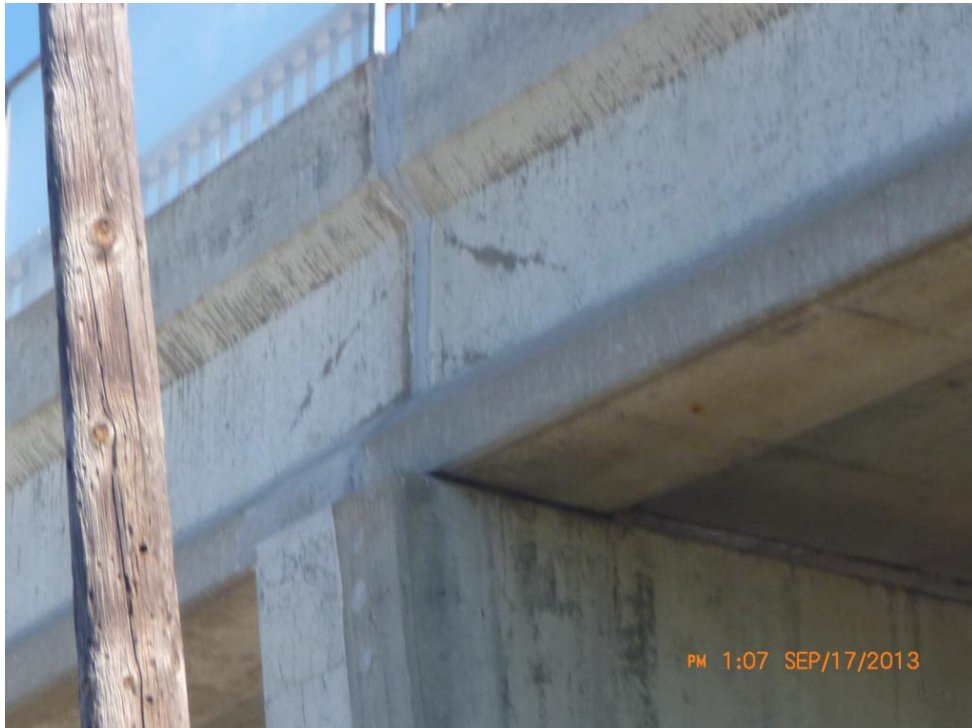
Comments: DIAGONAL CRACKING ON GIRDER END AT PIER

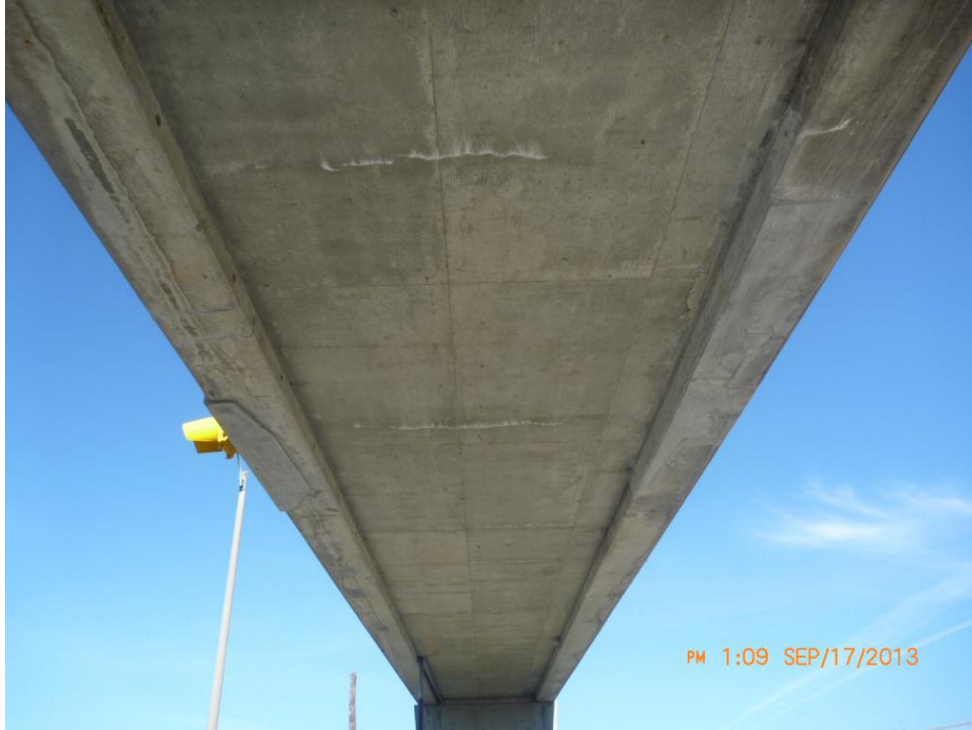
Comments: TYPICAL SOFFIT

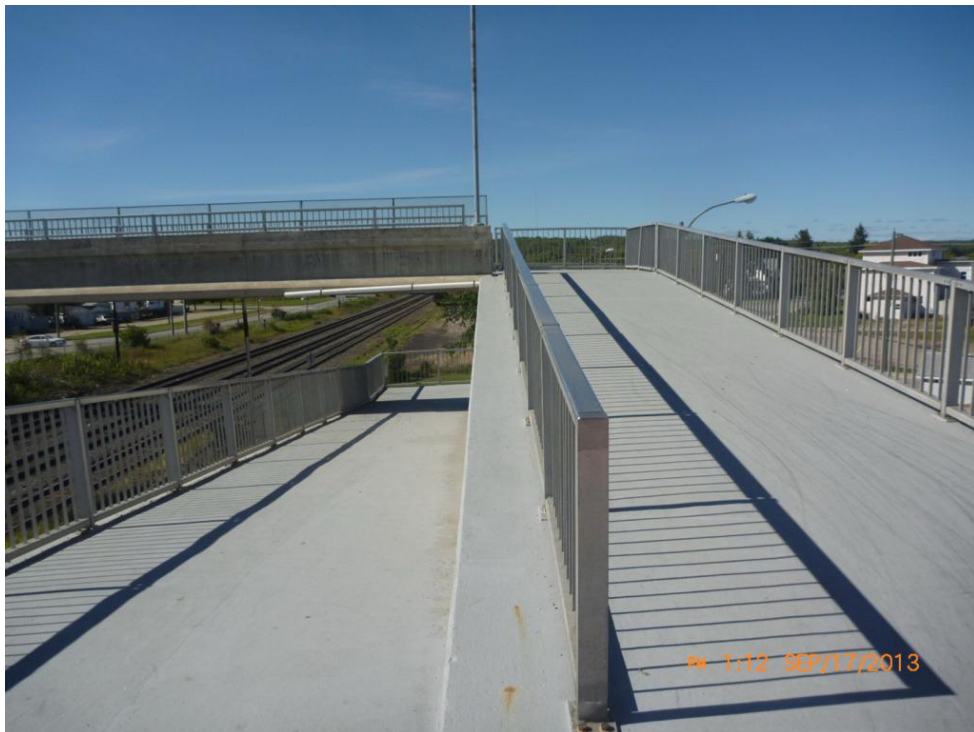
Comments: LOOKING NORTH AT PEDESTRIAN WALKWAY
