TOWNSHIP OF CHAPLEAU

MUNICIPAL STRUCTURE INVENTORY AND INSPECTION - 2013

AECOM

December, 2013

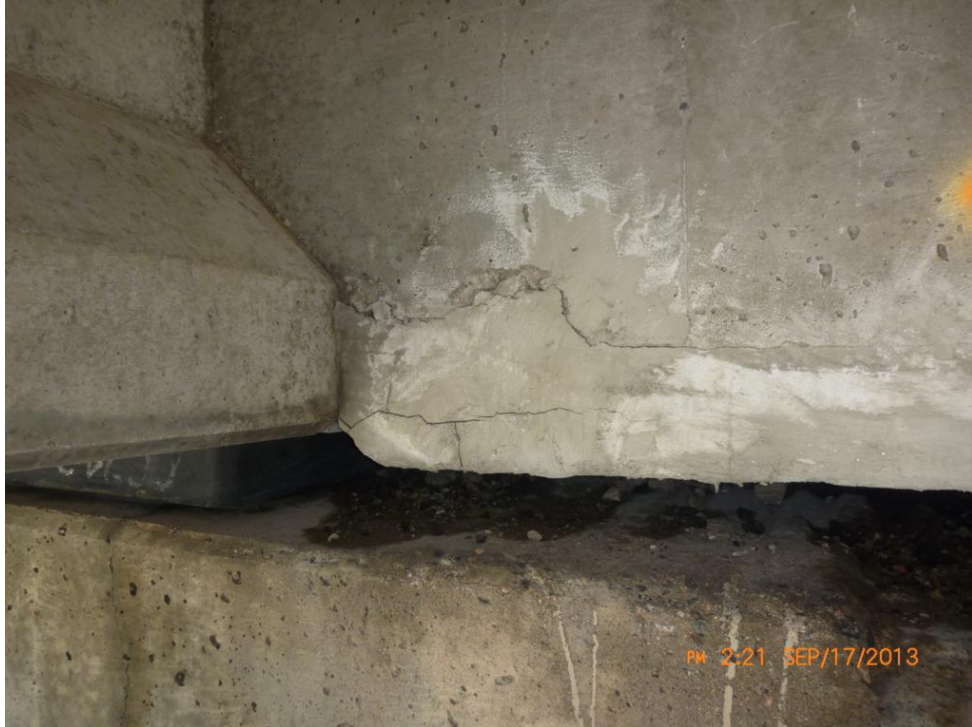
Comments: DEBONDED PATCH ON EAST ABUTMENT DIAPHRAGM

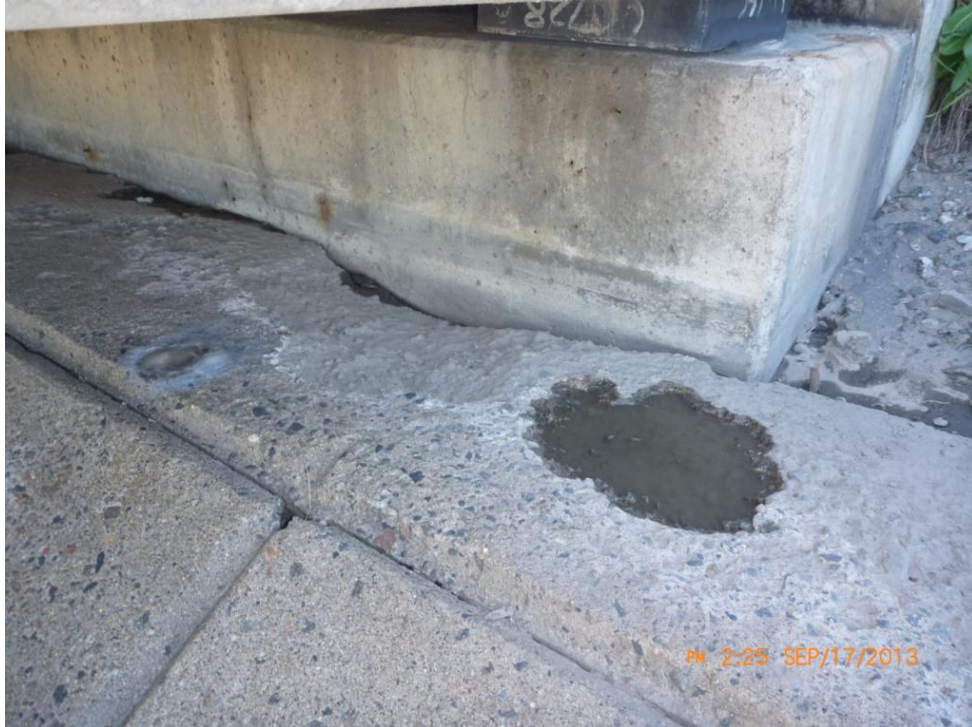
Comments: SEVERE SCALING OF SLOPE PROTECTION

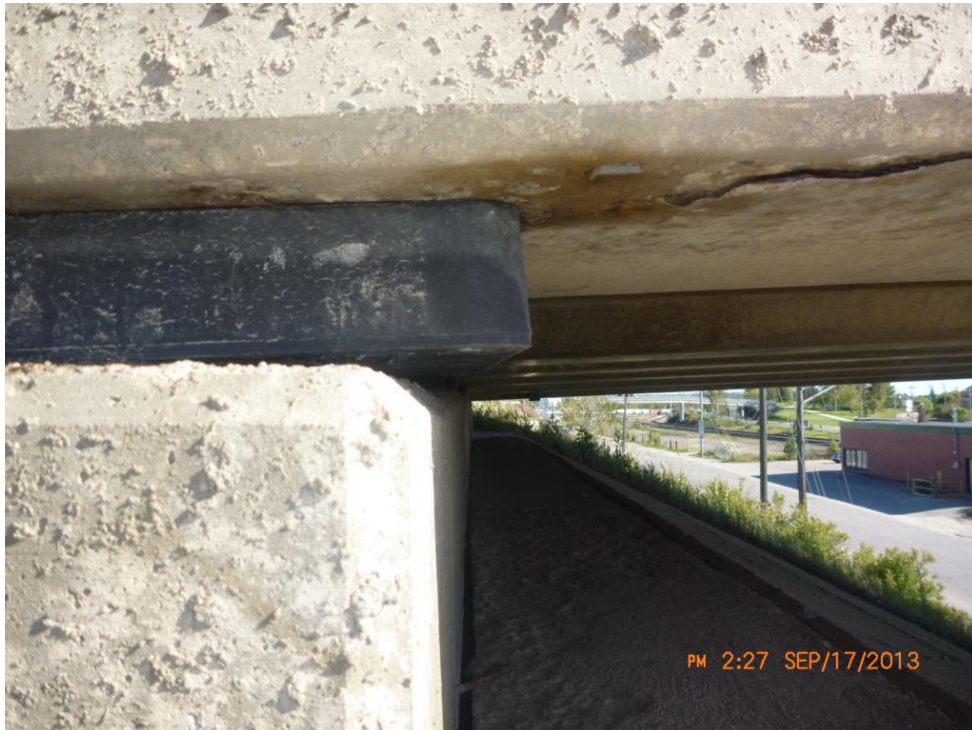
Comments: MOVEMENT OF BEARING PAD

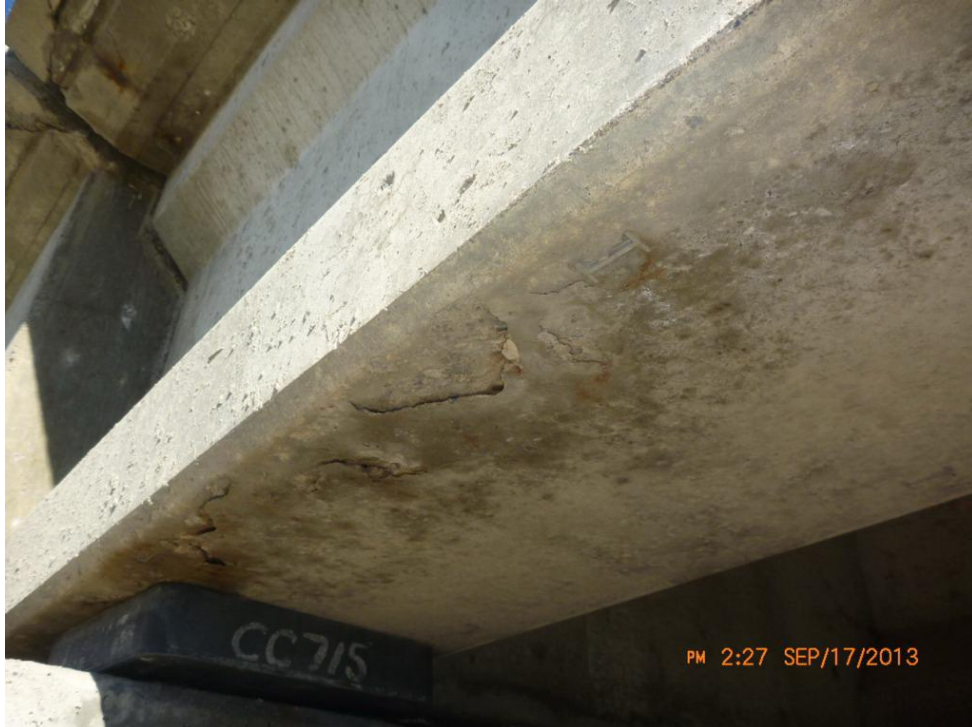
Comments: DELAMINATION AT GIRDER END

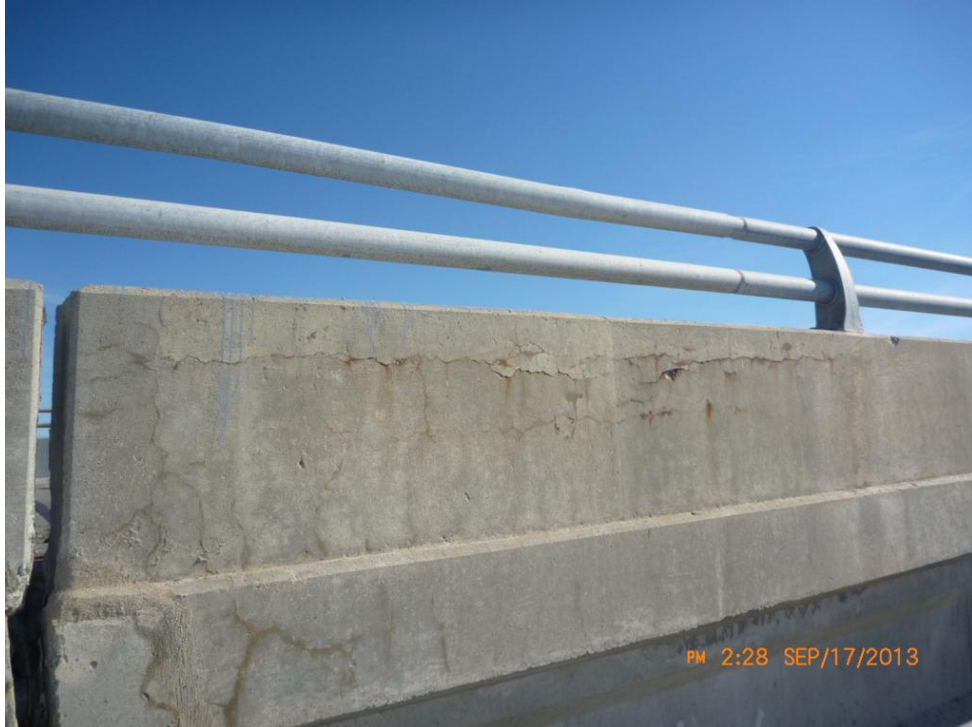
Comments: DELAMINATION ON BARRIER WALL

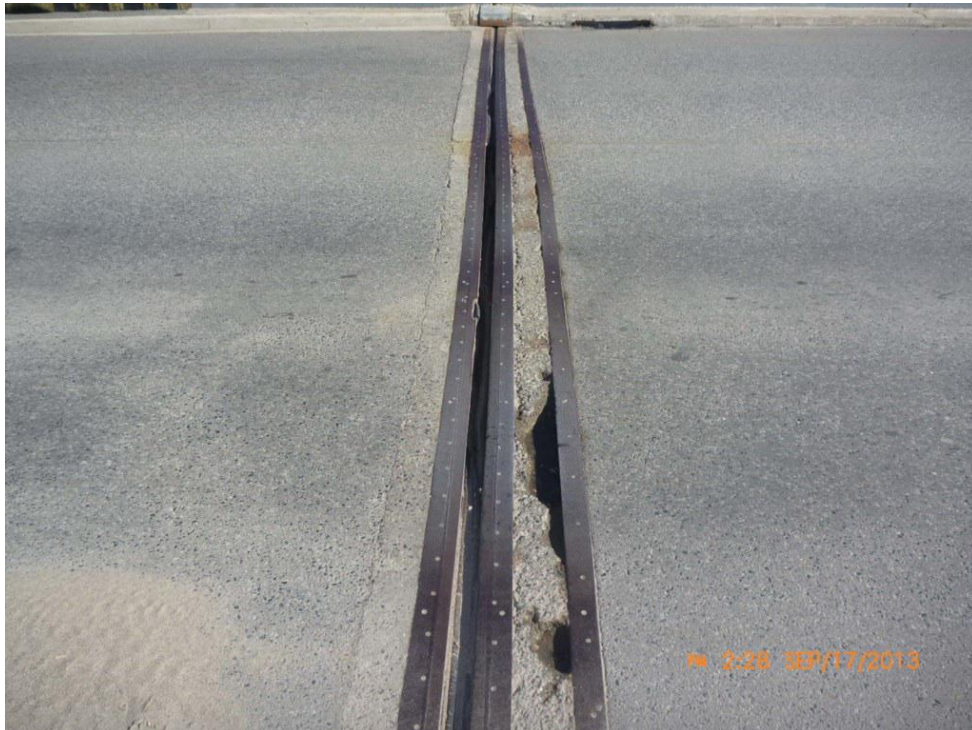
Comments: EAST EXPANSION JOINT

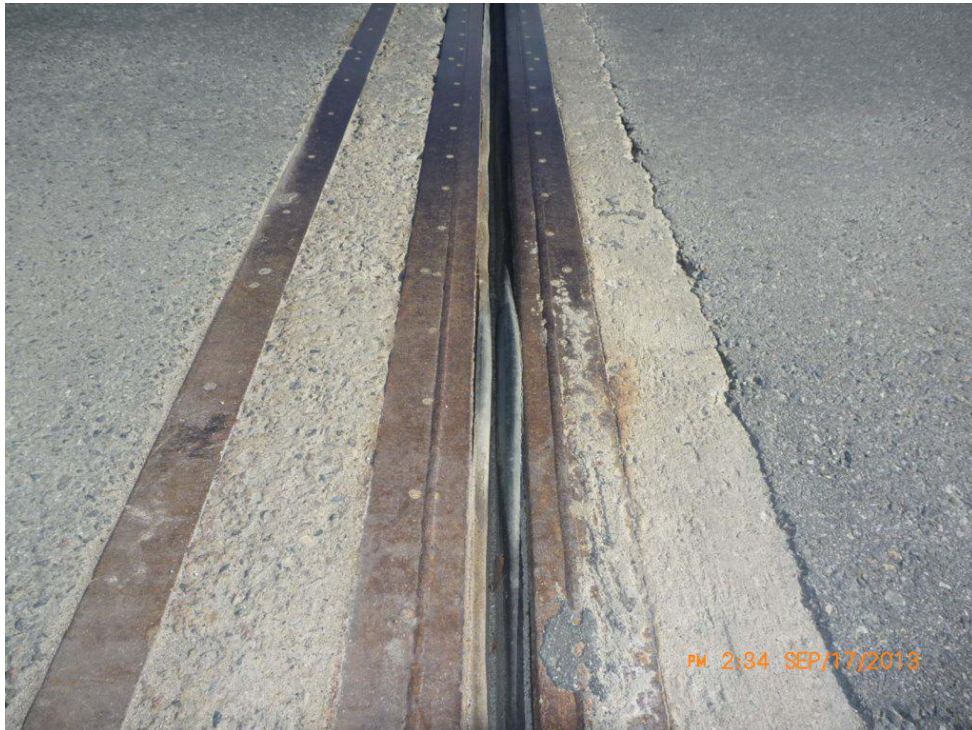
Comments: DEFORMATION OF WEST JOINT SEAL

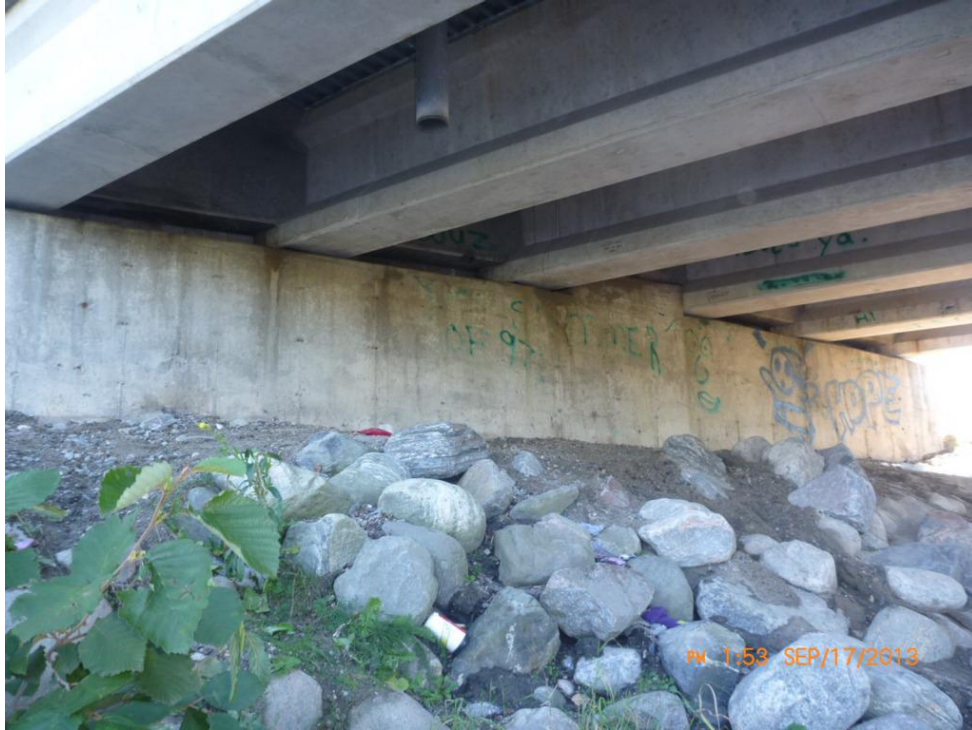
Comments: SOUTH ABUTMENT WALL

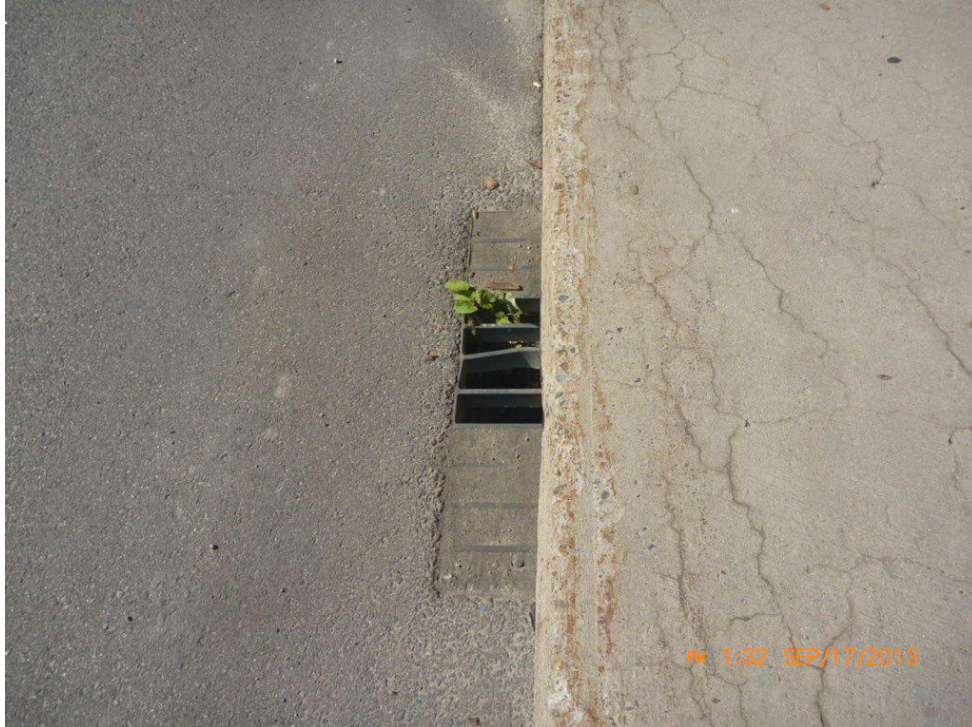
Comments: PARTIALLY PLUGGED DECK DRAIN

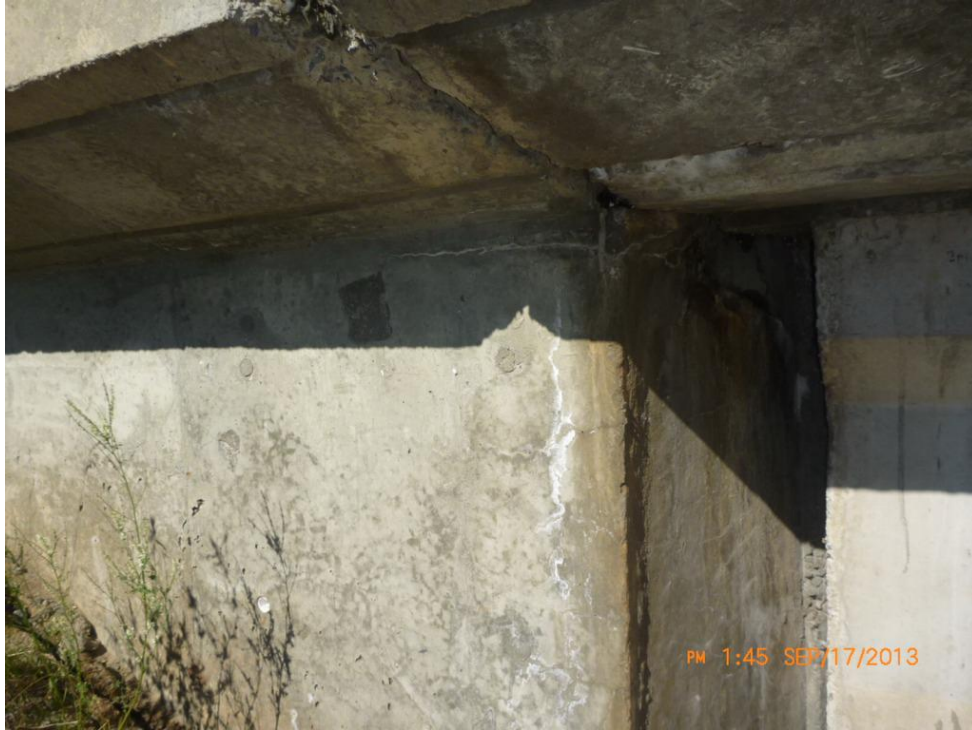
Comments: EFFLORESCENCE ON WINGWALL

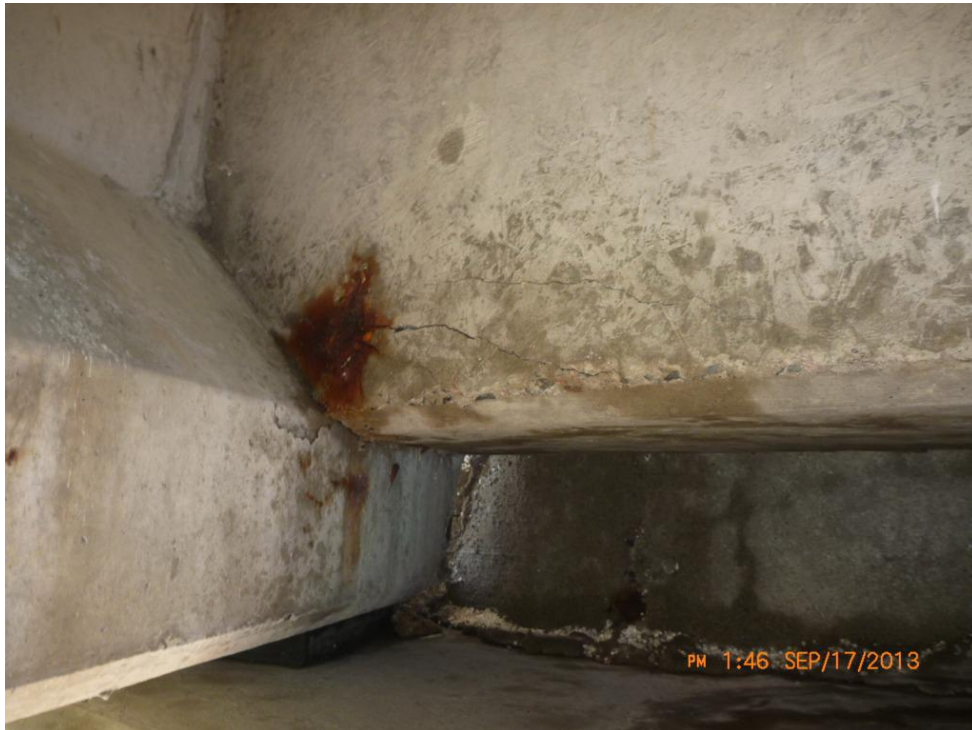
Comments: DELAMINATION ON DIAPHRAGM AT ABUTMENT

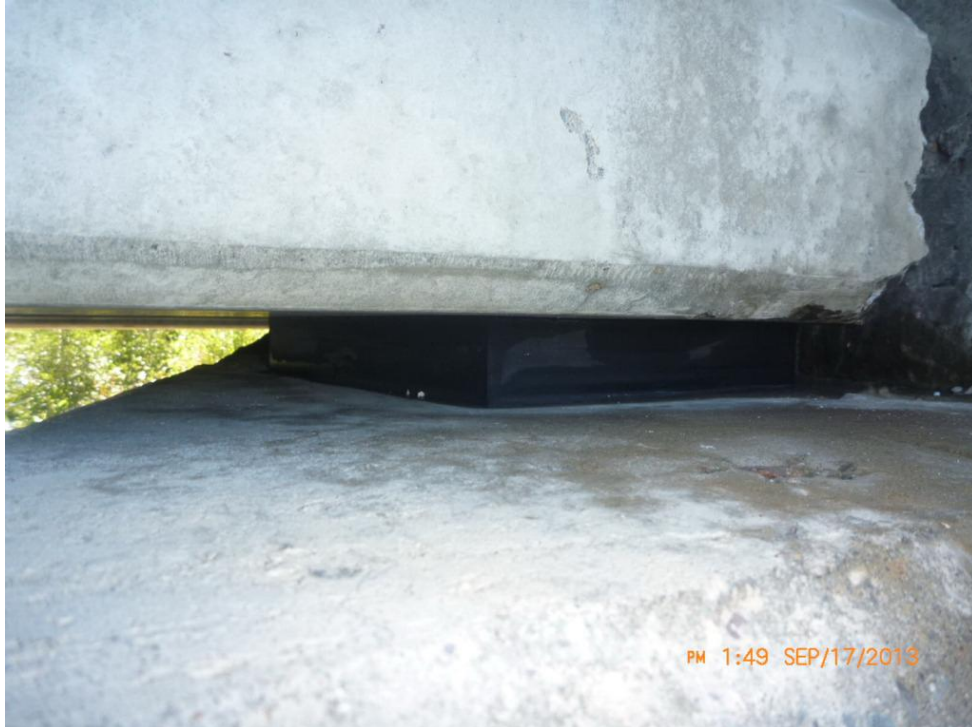
Comments: TYPICAL ABUTMENT BEARING

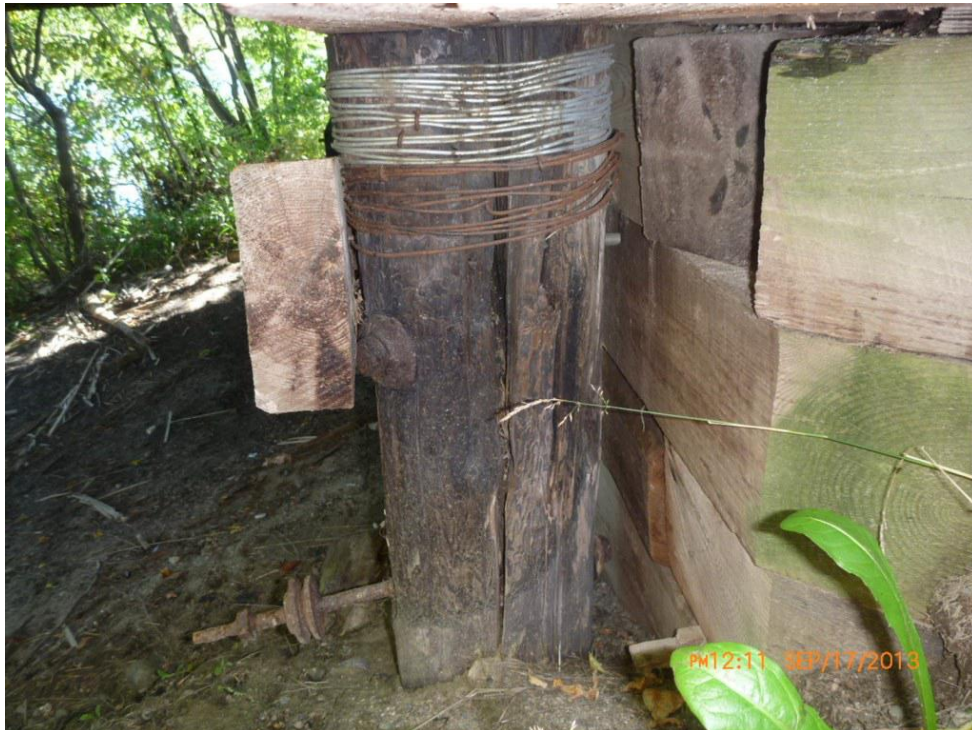
Comments: SEVERE SPLITTING OF ABUTMENT PILE

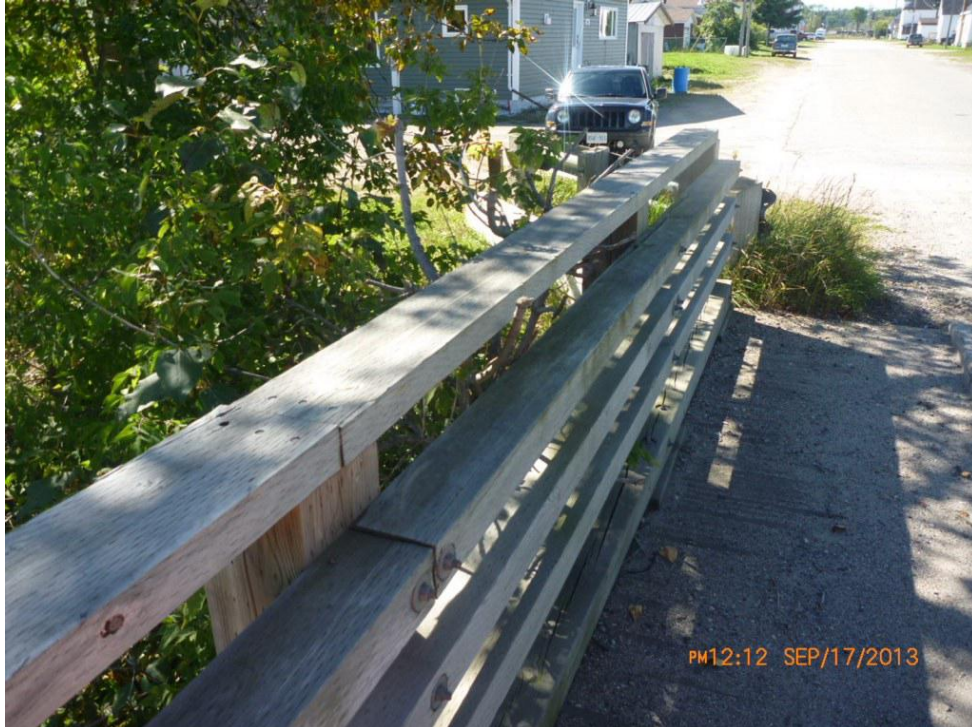
Comments: VEGETATION GROWTH THROUGH RAILING

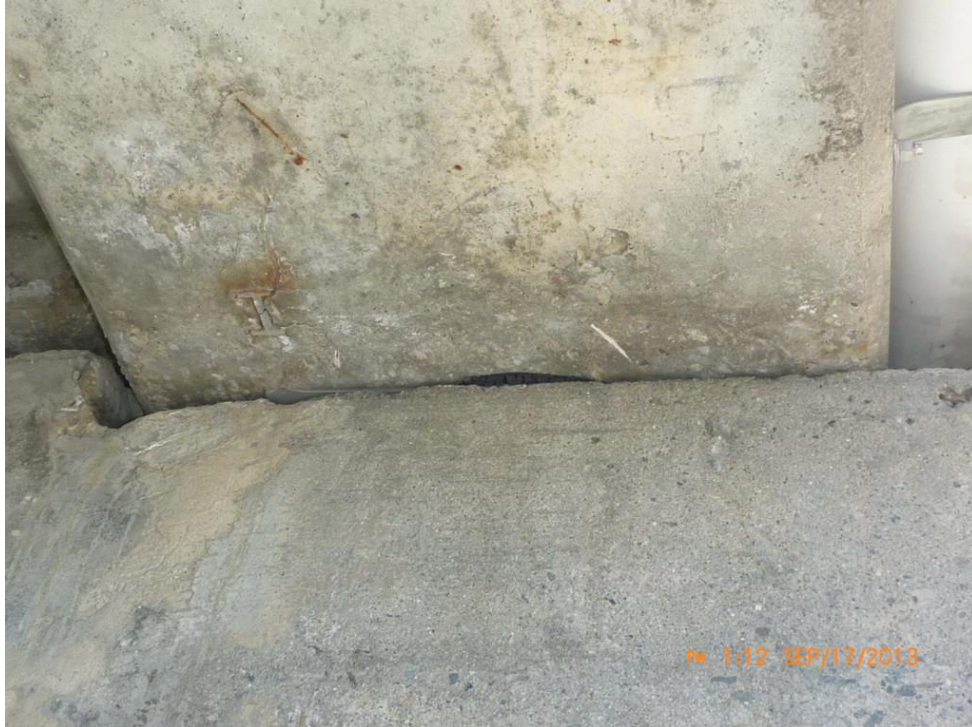
Comments: SQUASHING OF EAST ABUTMENT BEARING PAD
Path: E:\WorkTech Data\Chapleau\Photos\2013\Photo 048.JPG

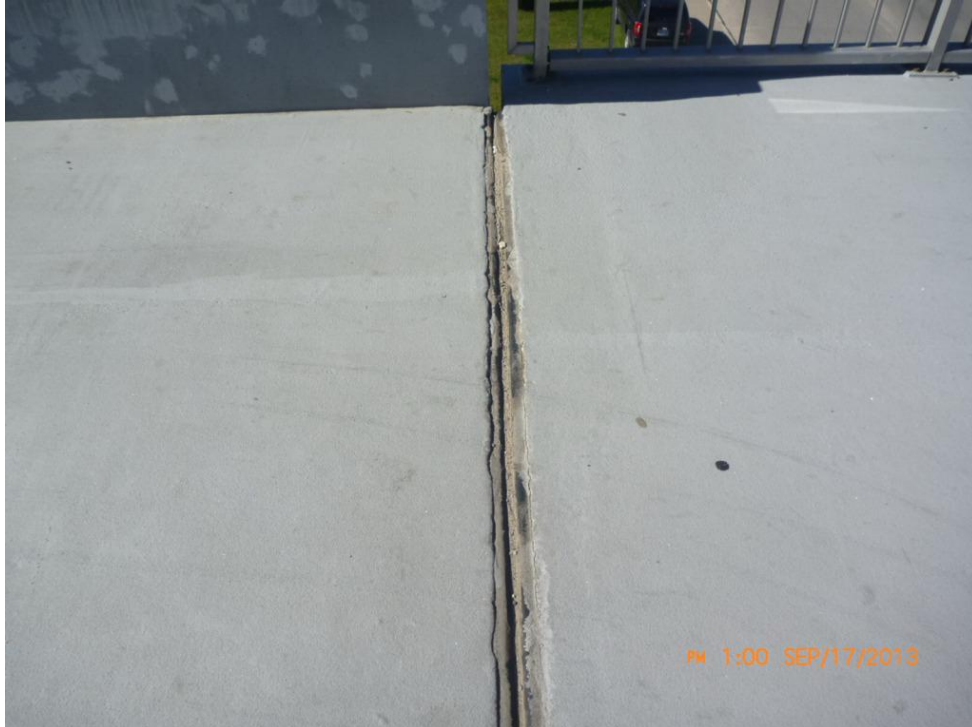
Comments: EAST EXPANSION JOINT

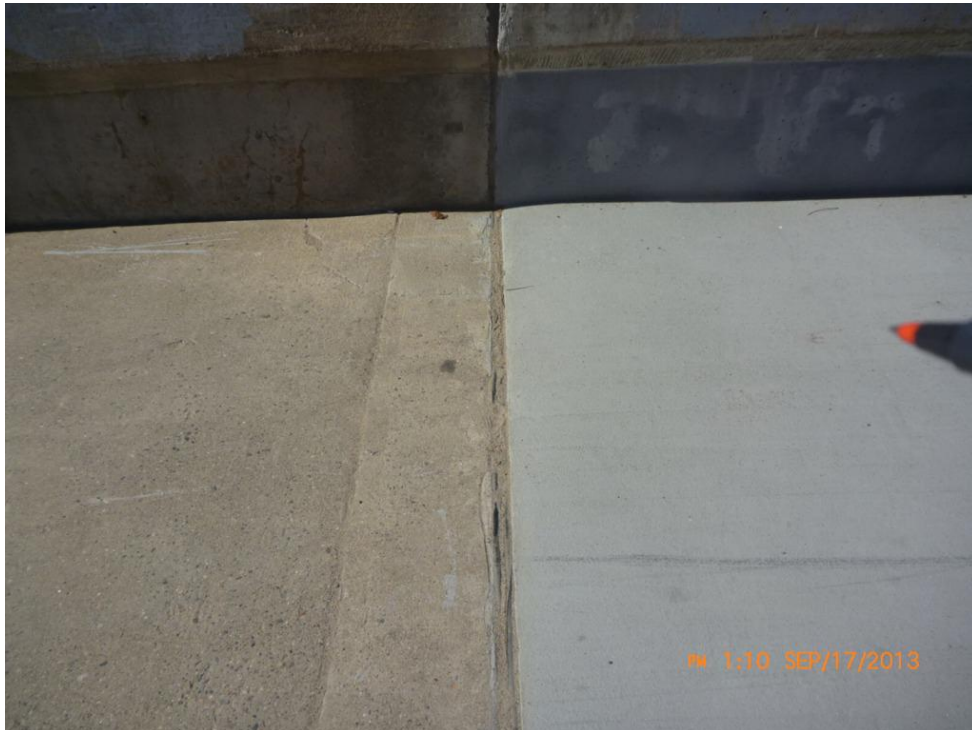
Comments: WEST EXPANSION JOINT

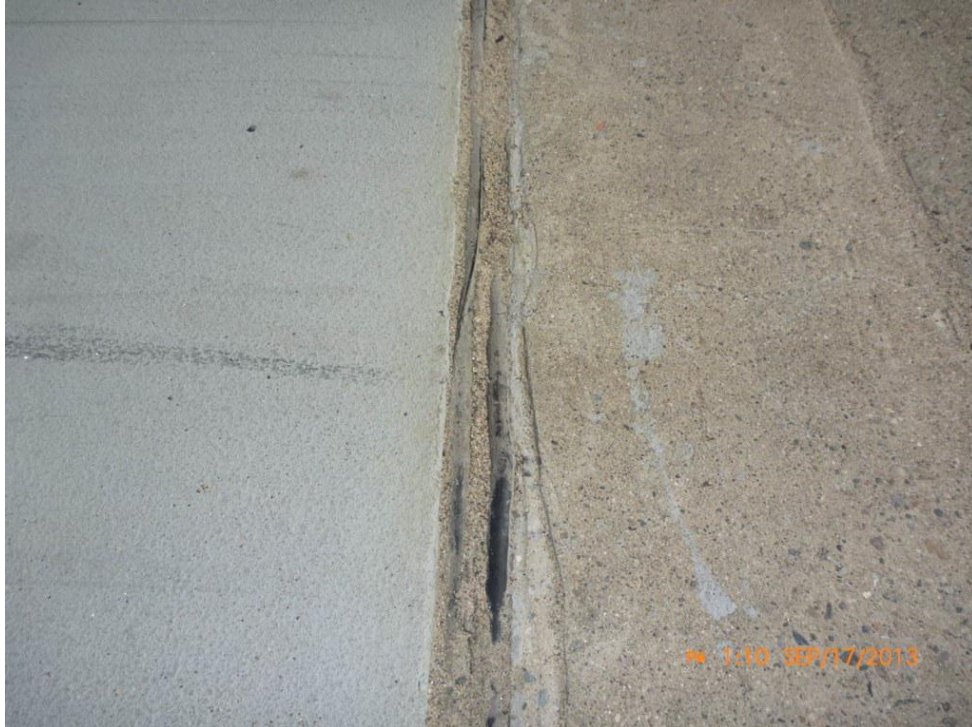
Comments: DEFORMATION OF WEST EXPANSION JOINT SEAL
