TOWNSHIP OF CHAPLEAU

MUNICIPAL STRUCTURE INVENTORY AND INSPECTION - 2013

AECOM

December, 2013

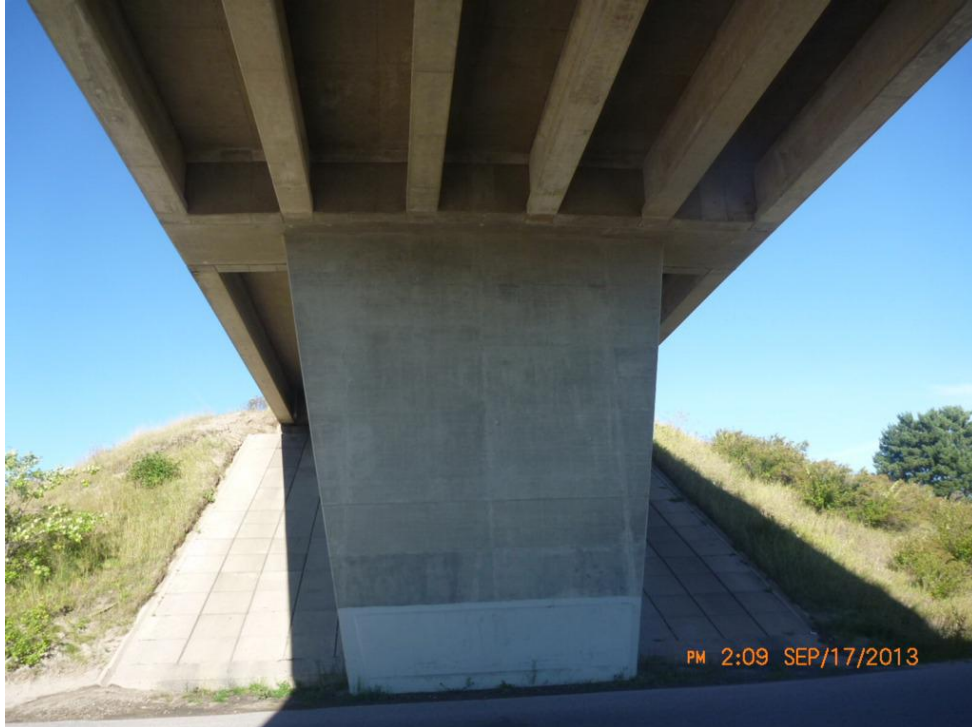
Comments: TYPICAL PIER

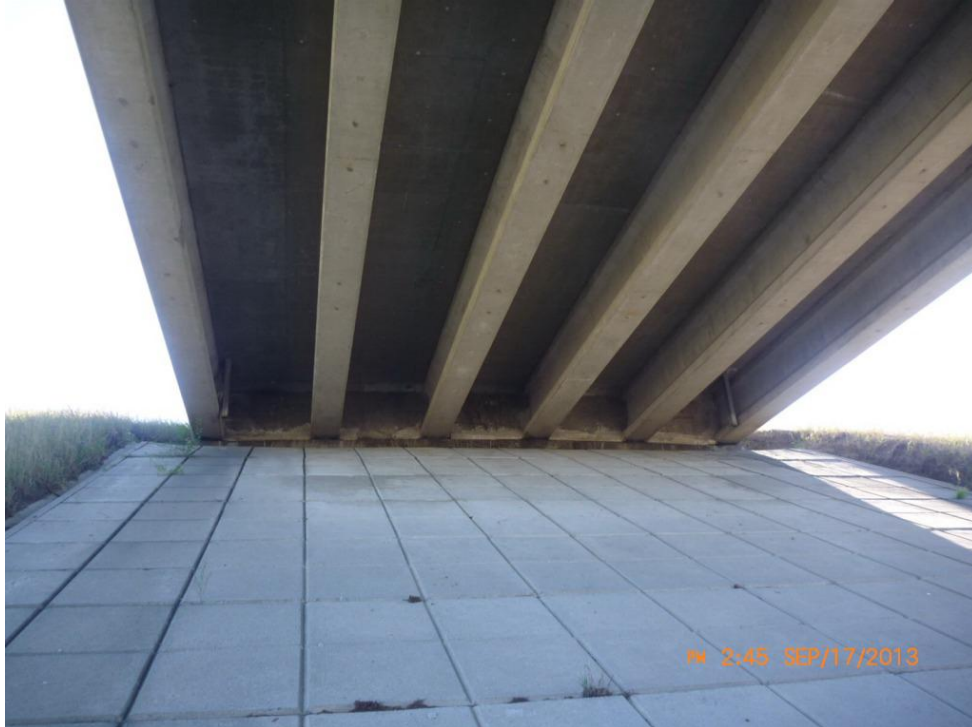
Comments: SOUTH ELEVATION

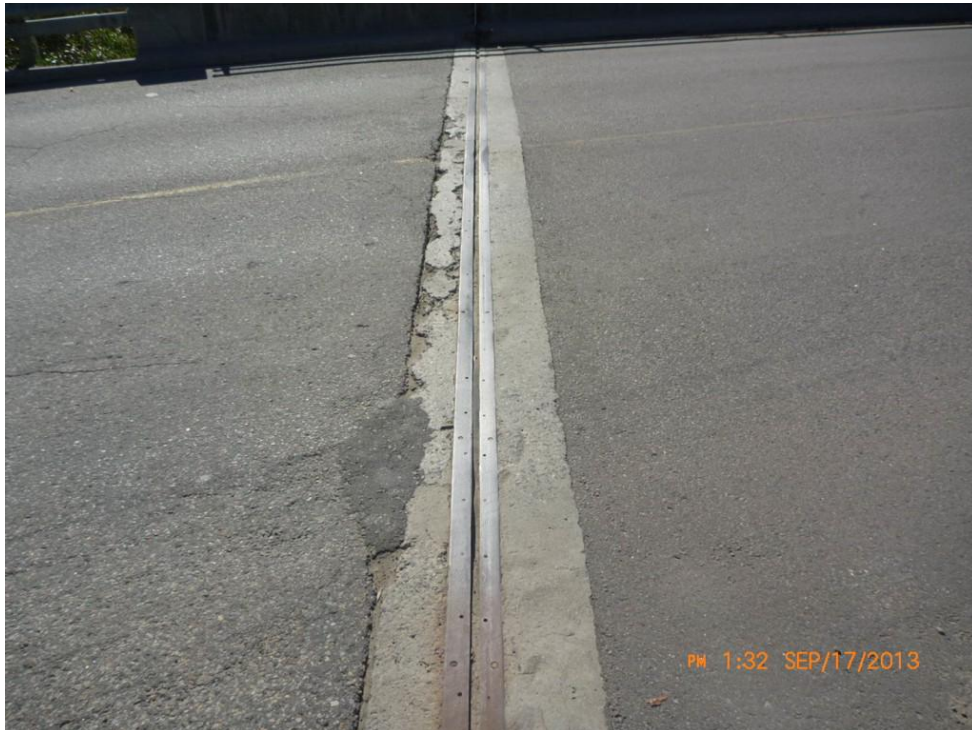
Comments: SOUTH EXPANSION JOINT

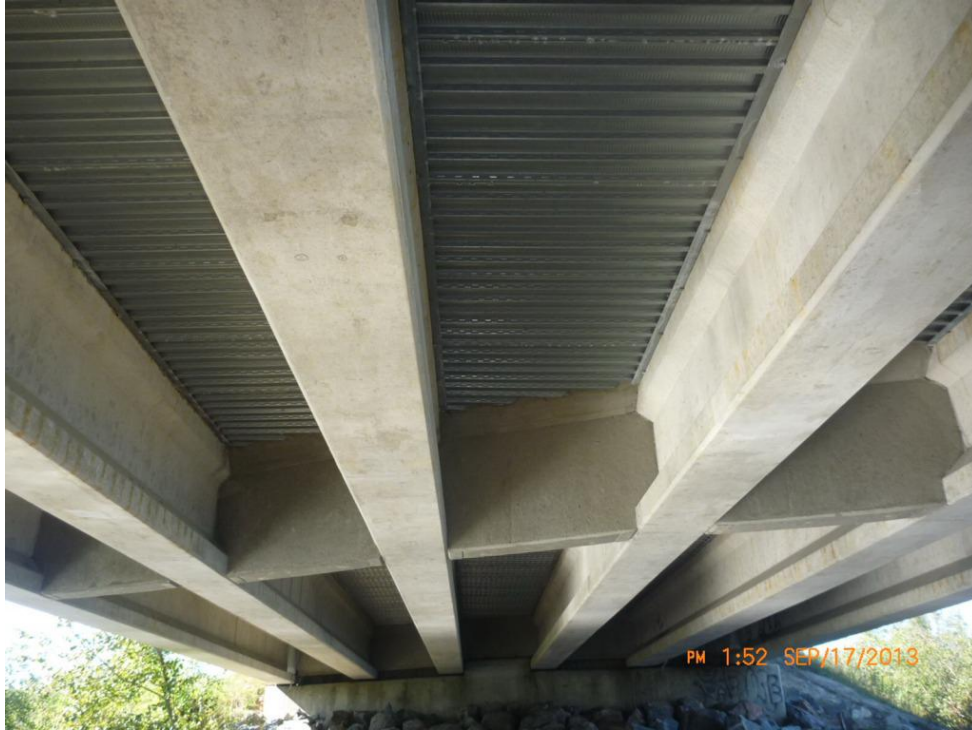
Comments: TYPICAL SOFFIT

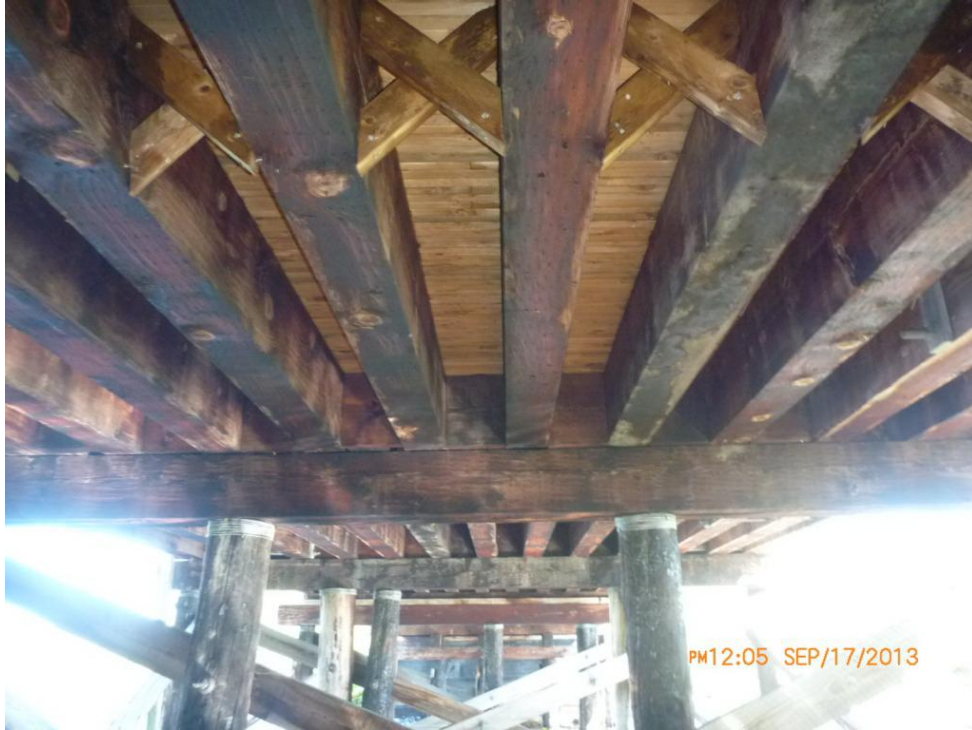
Comments: TYPICAL SOFFIT

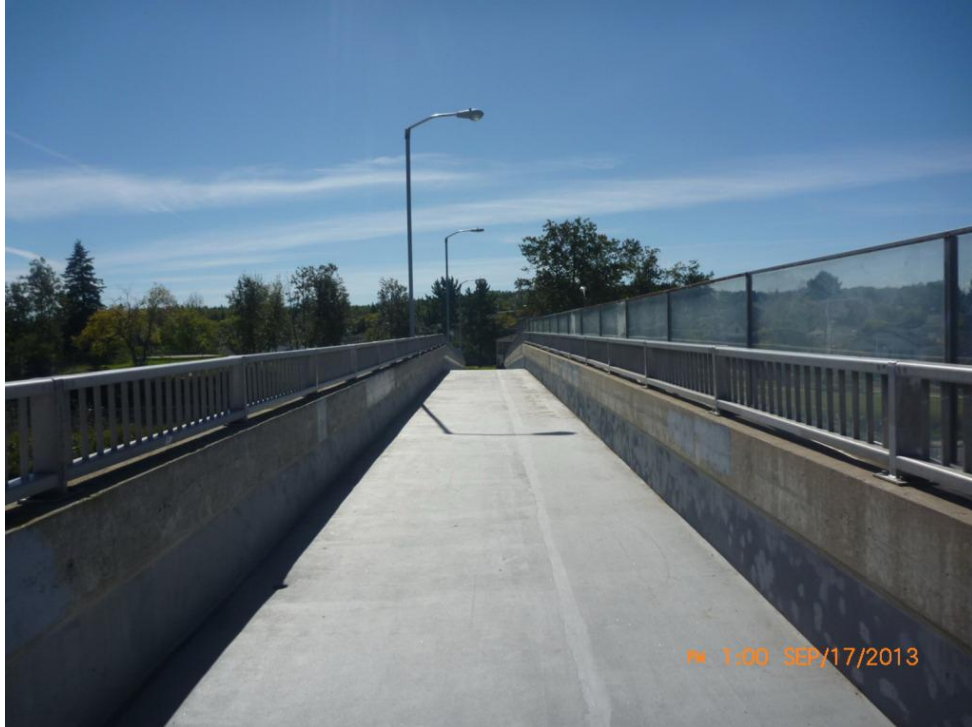
Comments: LOOKING WEST OVER STRUCTURE

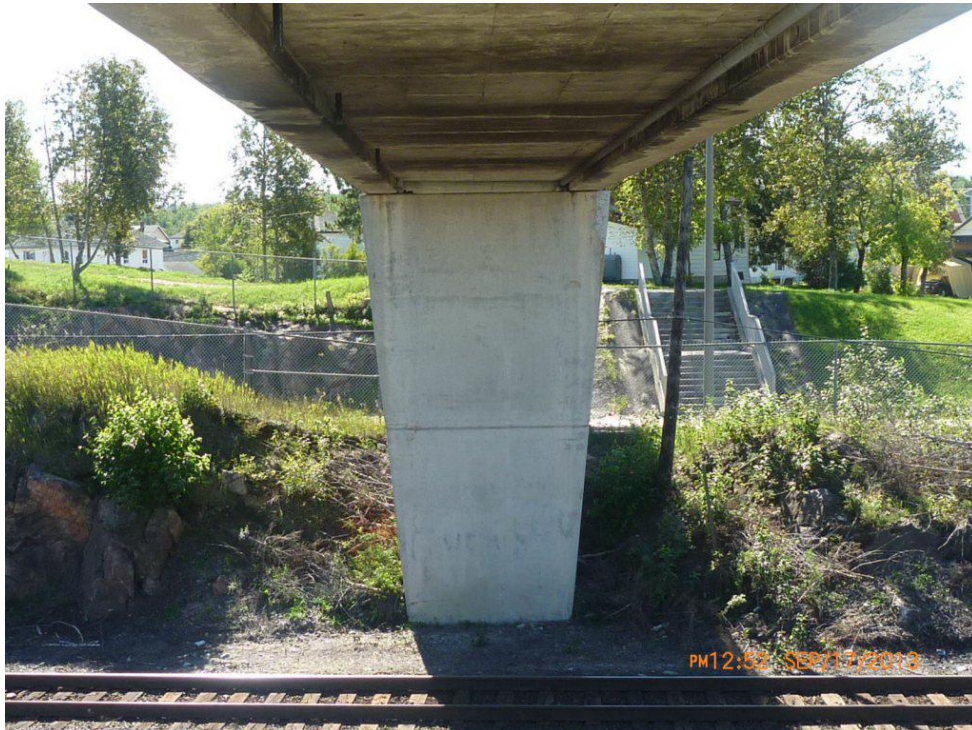
Comments: TYPICAL PIER
